# Poročilo o preskusu / Test Report

Št. / No.:	
T211-0057R/13	
Datum / Date:	
2013-02-07	
· · · · · · · · · · · · · · · · · · ·	
Proizvod / Product	Listov / Pages
Power supply Model: GT-41060(GTM41060, GT-41131, GTM41131)	7
	Vrsta preskusa /Test procedure
	IP52
Naročnik / Applicant	Št. Merjencev / No. of Items tested
GlobTek, Inc	
186 Veterans Dr, Northvale, NJ 07647 / USA	1
Proizvajalec / Manufacturer	Mapa predmeta št. / Subject File No.
GlobTek, Inc	
186 Veterans Dr, Northvale, NJ 07647 / USA	C20121856
Blagovna znamka / Trade Mark	Kraj preskusa / Place of test
GlobTek	SIQ - Slovenian Institute of Quality and Metrology, Tržaška 2, 1000 Ljubljana, Slovenia
Standardi – predpisi / Standards - regulations	Opomba / Remark
IEC 60529:2001	1
Zaključek / Conclusion	- fau averta attica da una ID 50
<b>Tested product complies with the requirements of stated standards</b> The test results relate only to the items tested.	s for protection degree in 52.
Date of receipt of test items:2013-01-28

Power supply, model GT-41060(GTM41060, GT-41131, GTM41131) was subjected to testing for IP52 degree of protection (Figures 1 to 3).

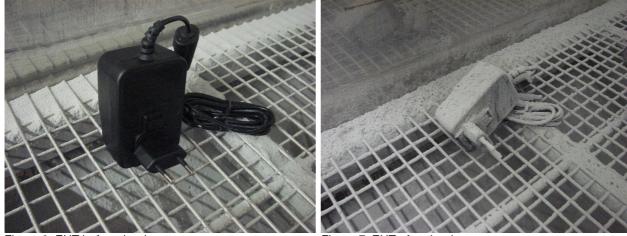
- Test chamber-as specified in standard,
- Dust, used for the test: talcum powder,
- Environmental temperature 24<sup>°</sup>C,
- No under pressure inside the enclosure,
- Duration of the exposure: 8 hours

Figure 6: EUT before the dust test

Figure 7: EUT after the dust test

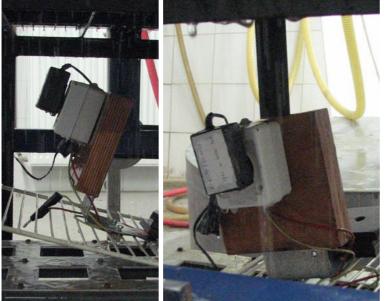
- Test device, drip box-as specified in standard,
- Water flow rate: 3 mm/min,
- The position of the test sample was fixed on 15<sup>0</sup> on either side of the vertical in two mutually perpendicular planes,
- The test sample was tested for 2.5 minutes in each of four fixed positions (Figures 8 to 11),
- The total duration of the exposure was 10 minutes

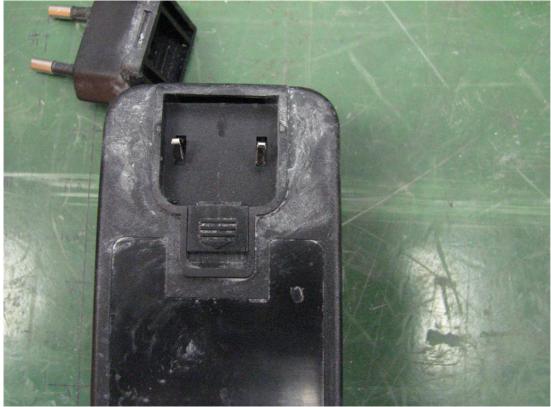
Figure 12

**Conclusion:** After the tests the enclosure was opened. There was no dust and no water inside the enclosure (Figures 12 to 16).

- There was no dust and no water inside the enclosure.
- There was no break down during the dielectric strength test.
