Poročilo o preskusu / Test Report

T211-0480/12

| Proizvod / Product | Listov / Pages |
|---|---|
| Power supply Model: GT-21089-WVVV-X.X-W3Z series GTM21089-WVVV-X.X-W3Z series, GT-41080-WVVV-X.X-W3Zseries GTM41080-WVVV-X.X-W3Z series GTM91075-6012-W3E GT-41080-WVVV-X.X-W3E, Enclosure: WR92A2600CCP-Y(R) | 4 |
| IEC 60529:2001 | SIQ - Slovenian Institute of Quality and Metrology, Tržaška 2, 1000 Ljubljana, Slovenia |

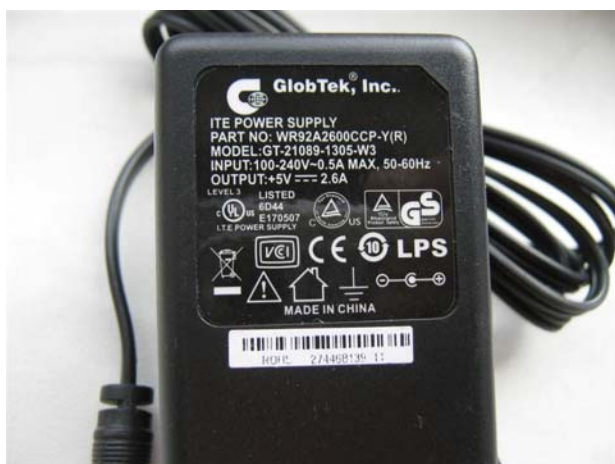
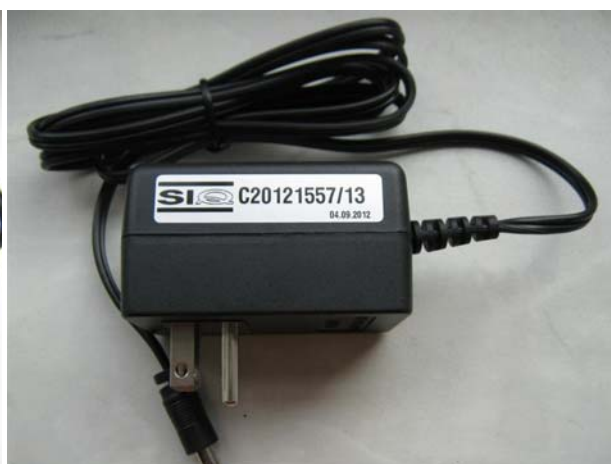
Figure 1

Power supply, model GT-21089-WWVV-X.X-W3Z series, GTM21089-WWVV-X.X-W3Z series, GT-41080-WWVV-X.X-W3Z series, GTM41080-WWVV-X.X-W3Z series, GTM91075-6012-W3E and GT-41080-WWVV-X.X-W3E, enclosure WR92A2600CCP-Y(R) was subjected to testing for IP41 degree of protection (Figures 1 and 2).

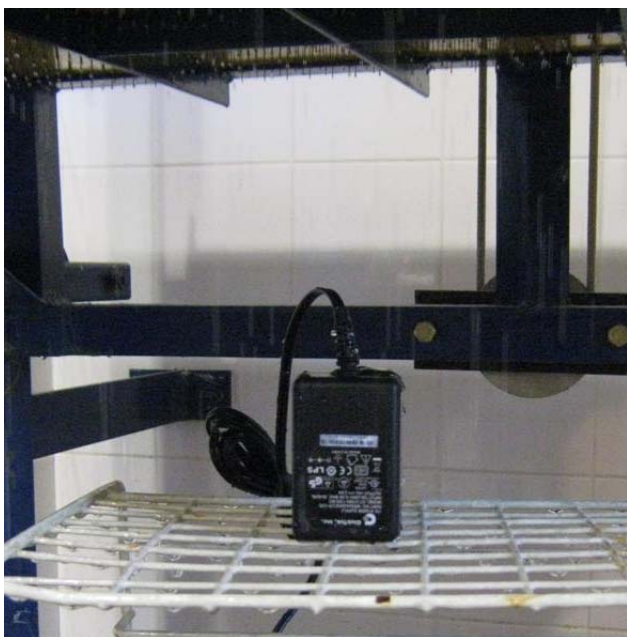
Figure 3: Test position

- Test device, drip box-as specified in standard,
- Water flow rate: 1 mm/min,
- The test sample was placed on the turntable under the drip box in most unfavourable normal position (Figures 3 and 4),
- Duration of the exposure: 10 minutes,
