Poročilo o preskusu / Test Report

T211-0482/12

Proizvod / *Product*
Power supply, Model: GT-41135-WWVV-X.X series, GT-41052-WWVV-X.X series, GT-43007-WWVV-X.X series, GT-41081-WWVV-X.X series, GT-41081-WWVV-X.X series GTH41080-WWVV-X.X series, GTM41080-WWVV-X.X series GTM41076-WWVV-X.X series, GT-41062-WWVV-X.X series Enclosure: WR9QA2000LCP-N(RVB)
Naročnik / *Applicant*
GlobTek, Inc 186 Veterans Dr, Northvale, NJ 07647 / USA
Proizvajalec / *Manufacturer*
GlobTek, Inc 186 Veterans Dr, Northvale, NJ 07647 / USA
Blagovna znamka / *Trade Mark*
GlobTek
Standardi – predpisi / *Standards - regulations*
IEC 60529:2001

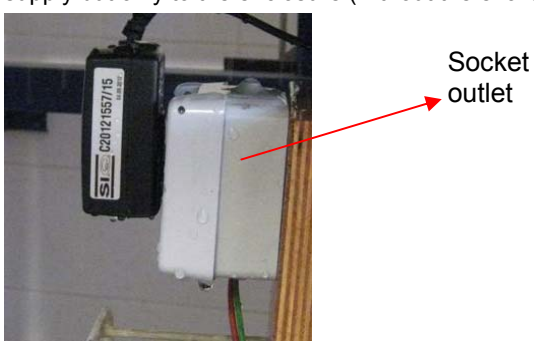
Figure 3: sample unit

During the testing the sample was equipped with exchangeable plug and connected to socket outlet, see Figure 3. The exchangeable plug part with the socket outlet was not subject of the test. Test results do not relate to the whole power supply but only to the enclosure (without the exchangeable plug part).
