Poročilo o preskusu / Test Report

T211-0454/12

Proizvod / *Product*	**Listov / *Pages***
Power supply Model: GT-41132-WWVV-X.X-T3 series GT-43008-WWVV-X.X-T3 series Enclosure: TR9CE5000LR10N(RVB)	3
	Vrsta preskusa /*Test procedure*
	IP40, IP41
Naročnik / *Applicant*	**Št. Merjencev / *No. of Items tested***
GlobTek, Inc 186 Veterans Dr, Northvale, NJ 07647 / USA	1
Proizvajalec / *Manufacturer*	**Mapa predmeta št. / *Subject File No.***
GlobTek, Inc 186 Veterans Dr, Northvale, NJ 07647 / USA	C20121557
Blagovna znamka / *Trade Mark*	**Kraj preskusa / *Place of test***
GlobTek	SIQ - Slovenian Institute of Quality and Metrology, Tržaška 2, 1000 Ljubljana, Slovenia
Standardi – predpisi / *Standards - regulations*	**Opomba / *Remark***
IEC 60529:2001	/

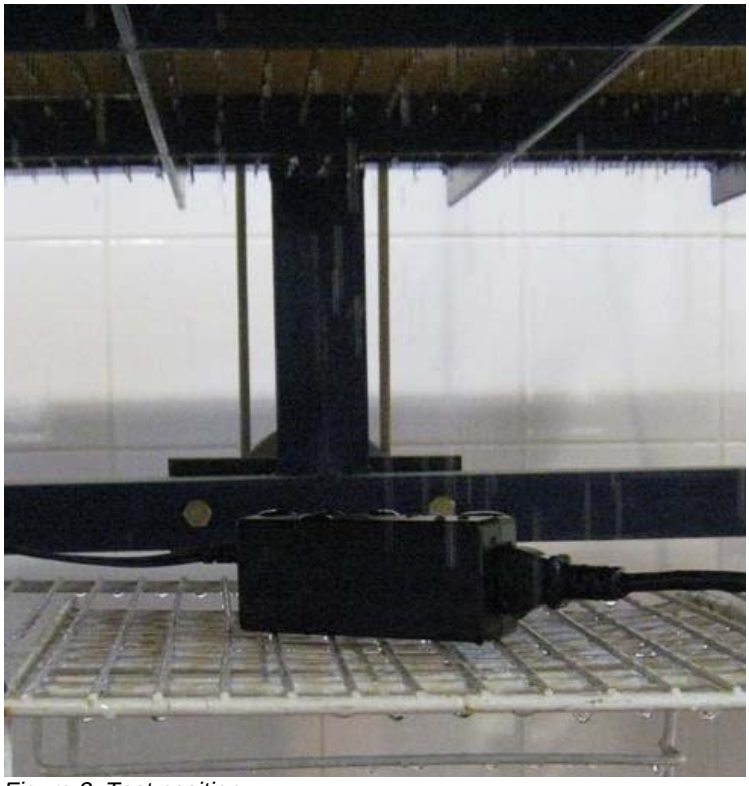
Figure 3: Test position

Conclusion: After the water test there was water on the connector pins.

Immediately following the water test the dielectric strength test with 4000 V a.c. has been conducted between primary and secondary terminals and between primary terminals and enclosure. The voltage was applied and maintained for a period of one minute between the points indicated. The test did NOT pass.

- The rigid test wire was not penetrated into the enclosure
- After the IPX1 test there was water on connector pins.
- After the IPX1 test the dielectric strength test did NOT pass.
