Poročilo o preskusu / Test Report

T211-0460/12

Proizvod / Product Power supply Model: GT-21148-WVVV-X.X-T3 series Enclosure: TR9LB4200LCP-Y(R)	Listov / Pages 3
Naročnik / Applicant GlobTek, Inc 186 Veterans Dr, Northvale, NJ 07647 / USA	Vrsta preskusa / Test procedure IP40, IP41
Proizvajalec / Manufacturer GlobTek, Inc 186 Veterans Dr, Northvale, NJ 07647 / USA	Št. Merjencev / No. of Items tested 1
Blagovna znamka / Trade Mark GlobTek	Mapa predmeta št. / Subject File No. C20121557
Standardi – predpisi / Standards - regulations IEC 60529:2001	Kraj preskusa / Place of test SIQ - Slovenian Institute of Quality and Metrology, Tržaška 2, 1000 Ljubljana, Slovenia
	Opomba / Remark /

Tested product complies with the requirements of stated standards for protection degree IP 40.

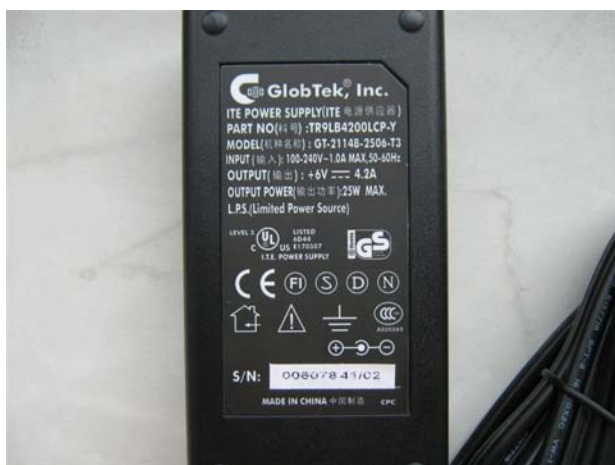
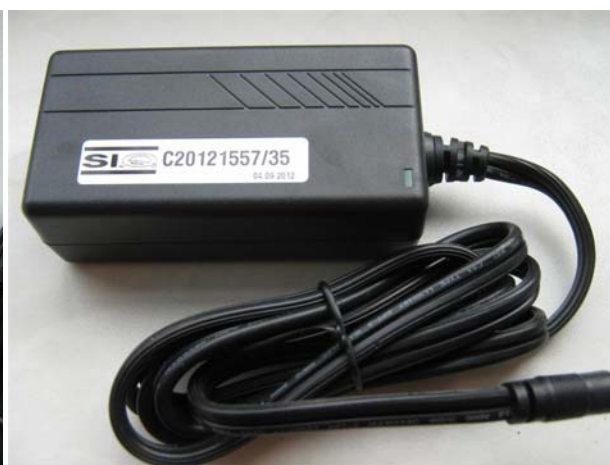
Figure 1

Power supply, model GTGT-21148-WWVV-X.X-T3 series, enclosure TR9LB4200LCP-Y(R) was subjected to testing for IP41 degree of protection (Figures 1 and 2).

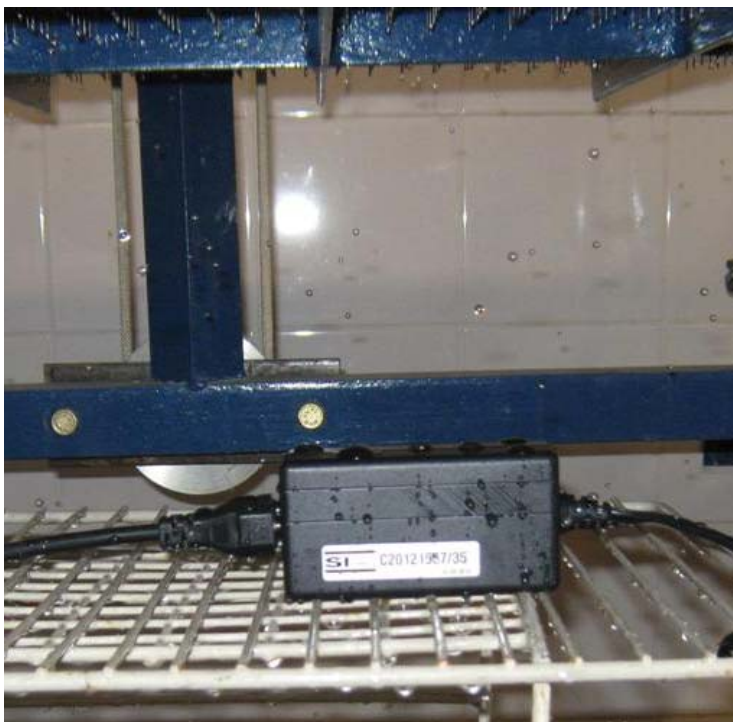
Figure 3: Test position

- Test device, drip box-as specified in standard,
- Water flow rate: 1 mm/min,
- The test sample was placed on the turntable under the drip box in most unfavourable normal position (Figure 3),
- Duration of the exposure: 10 minutes,

Conclusion: After the water test there was water on the connector pins.

Immediately following the water test the dielectric strength test with 4000 V a.c. has been conducted between primary and secondary terminals and between primary terminals and enclosure. The voltage was applied and maintained for a period of one minute between the points indicated. The test did NOT pass.

- The rigid test wire was not penetrated into the enclosure
- After the IPX1 test there was water on connector pins.
- After the IPX1 test the dielectric strength test did NOT pass.

Result: Following the acceptance conditions, the equipment under test sustained the test conditions for IP40 degree of protection.
