Poročilo o preskusu / Test Report

T211-0481/12

Proizvod / Product Power supply Model: GT-41131-WVVV-X.X series, GTM41133-WVVV-X.X series, GT-41060-WVVV-X.X series, GTM41060-WVVV-X.X series, GTM41070-WVVV-X.X series Enclosure: WR9QE2000C9P-N(RVB)	Listov / Pages 4
Naročnik / Applicant GlobTek, Inc 186 Veterans Dr, Northvale, NJ 07647 / USA	Vrsta preskusa / Test procedure IP40, IP41
Proizvajalec / Manufacturer GlobTek, Inc 186 Veterans Dr, Northvale, NJ 07647 / USA	Št. Merjencev / No. of Items tested 1
Blagovna znamka / Trade Mark GlobTek	Mapa predmeta št. / Subject File No. C20121557
Standardi – predpisi / Standards – regulations IEC 60529:2001	Kraj preskusa / Place of test SIQ - Slovenian Institute of Quality and Metrology, Tržaška 2, 1000 Ljubljana, Slovenia
	Opomba / Remark /

Tested product complies with the requirements of stated standards for protection degree IP 40.

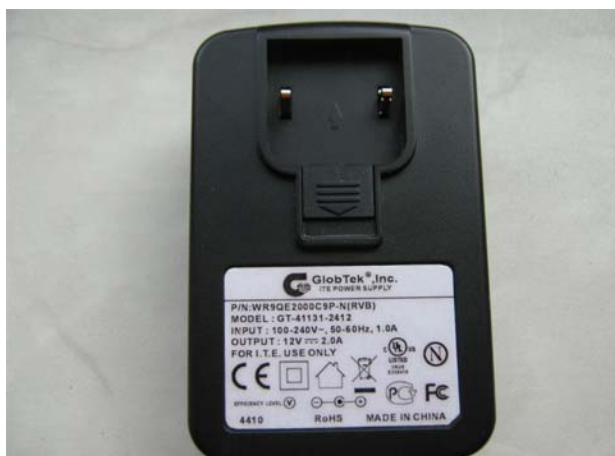
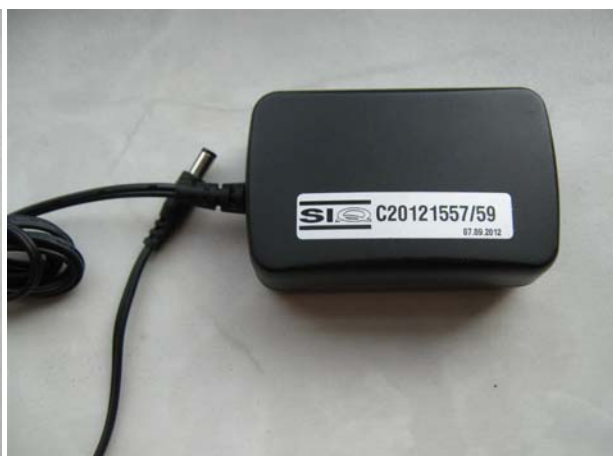
Figure 1

Power supply, model GT-41131-WWVV-X.X series, GTM41133-WWVV-X.X series, GT-41060-WWVV-X.X series, GTM41060-WWVV-X.X series and GTM41070-WWVV-X.X series, enclosure WR9QE2000C9P-N(RVB) was subjected to testing for IP41 degree of protection (Figures 1 and 2).

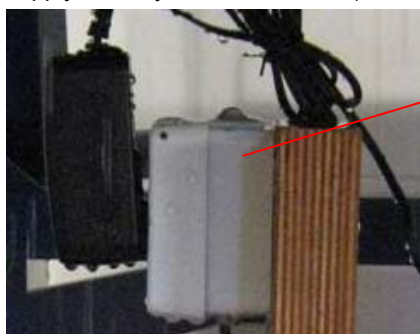
Figure 3: sample unit

During the testing the sample was equipped with exchangeable plug and connected to socket outlet, see Figure 3. The exchangeable plug part with the socket outlet was not subject of the test. Test results do not relate to the whole power supply but only to the enclosure (without the exchangeable plug part).

Socket
outlet

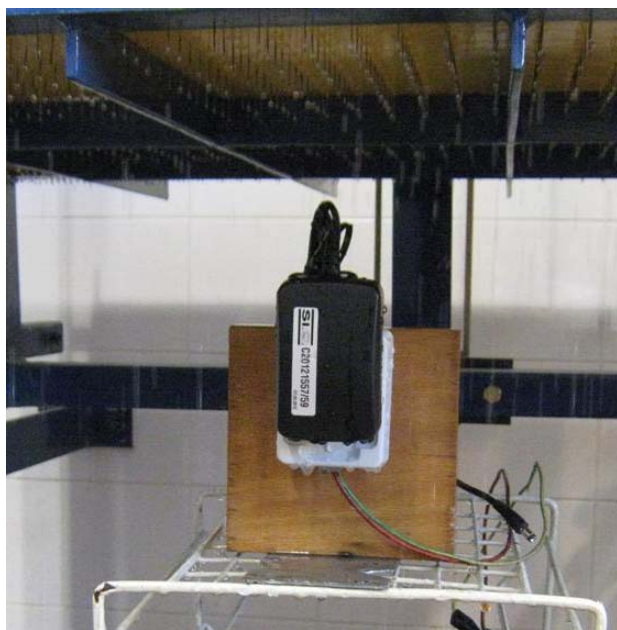
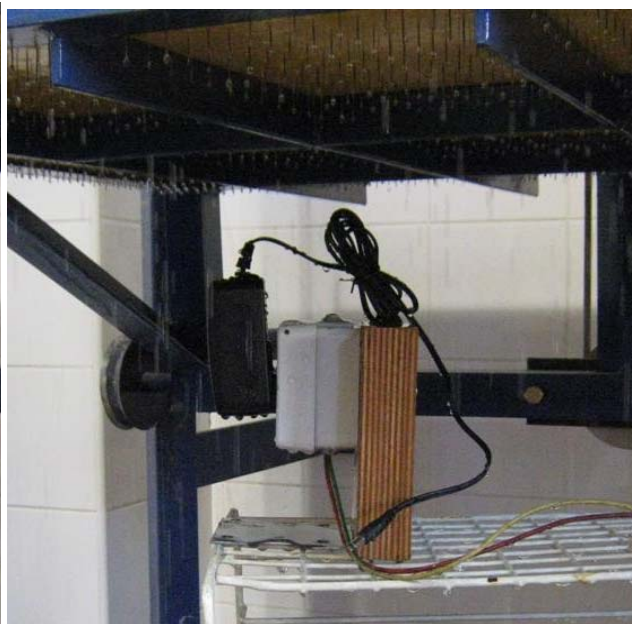
Figure 4: Test position

- Test device, drip box-as specified in standard,
- Water flow rate: 1 mm/min,
- The test sample was placed on the turntable under the drip box in most unfavourable normal position (Figures 4 and 5),
- Duration of the exposure: 10 minutes,

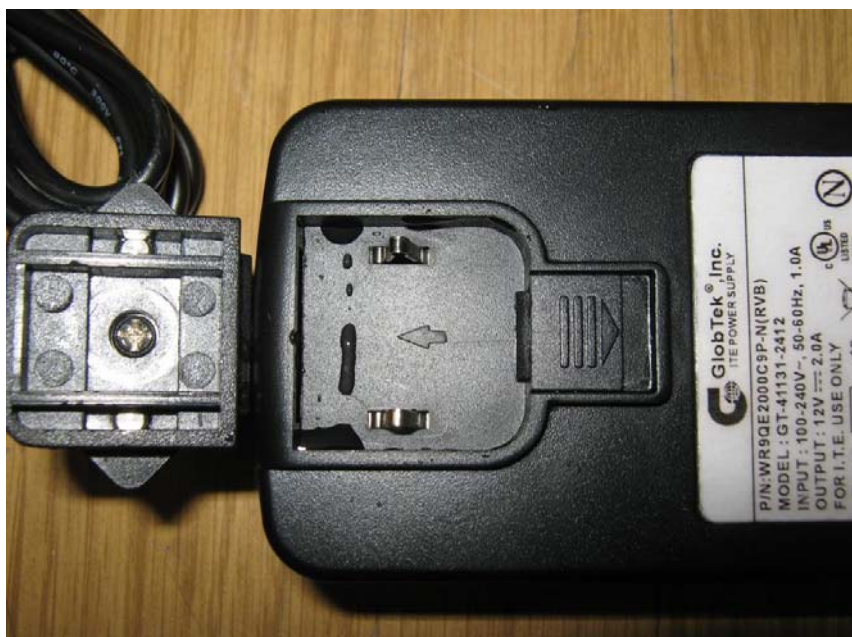
Figure 6

Conclusion: After the water test there was water on the appliance pins (Figure 6).

- The rigid test wire was not penetrated into the enclosure
- After the IPX1 test there was water on appliance pins.

Result: Following the acceptance conditions, the equipment under test sustained the test conditions for IP40 degree of protection.
