Slovenski institut za
kakovost in meroslovje

Poročilo o preskusu / Test Report

T211-0468/12

Proizvod / Product	Listov / Pages
Power supply Model: GT-41069P9012-T2	3
Naročnik / Applicant	Vrsta preskusa / Test procedure
GlobTek, Inc 186 Veterans Dr, Northvale, NJ 07647 / USA	IP40, IP41
Proizvajalec / Manufacturer	Št. Merjencev / No. of Items tested
GlobTek, Inc 186 Veterans Dr, Northvale, NJ 07647 / USA	1
Blagovna znamka / Trade Mark	Mapa predmeta št. / Subject File No.
GlobTek	C20121557
Standardi - predpisi / Standards - regulations	Kraj preskusa / Place of test
IEC 60529:2001	SIQ - Slovenian Institute of Quality and Metrology, Tržaška 2, 1000 Ljubljana, Slovenia
	Opomba / Remark
	/

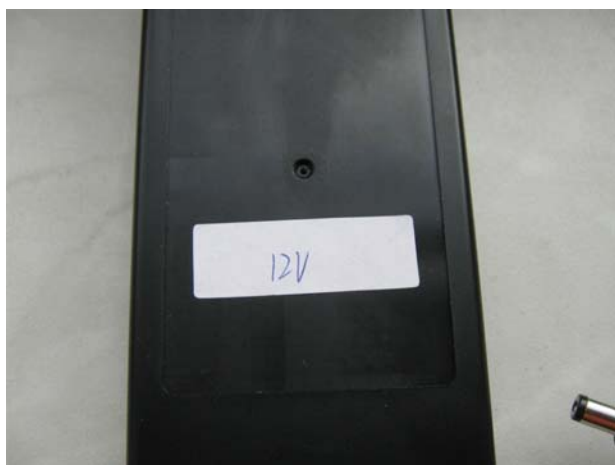
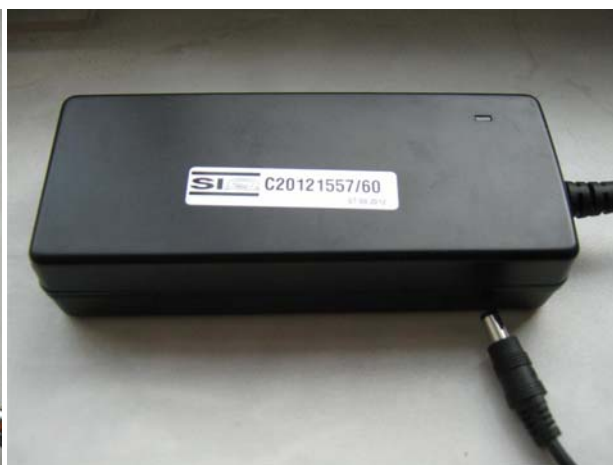
Figure 1

Power supply, model GT-41069P9012-T2, was subjected to testing for IP41 degree of protection (Figures 1 and 2).

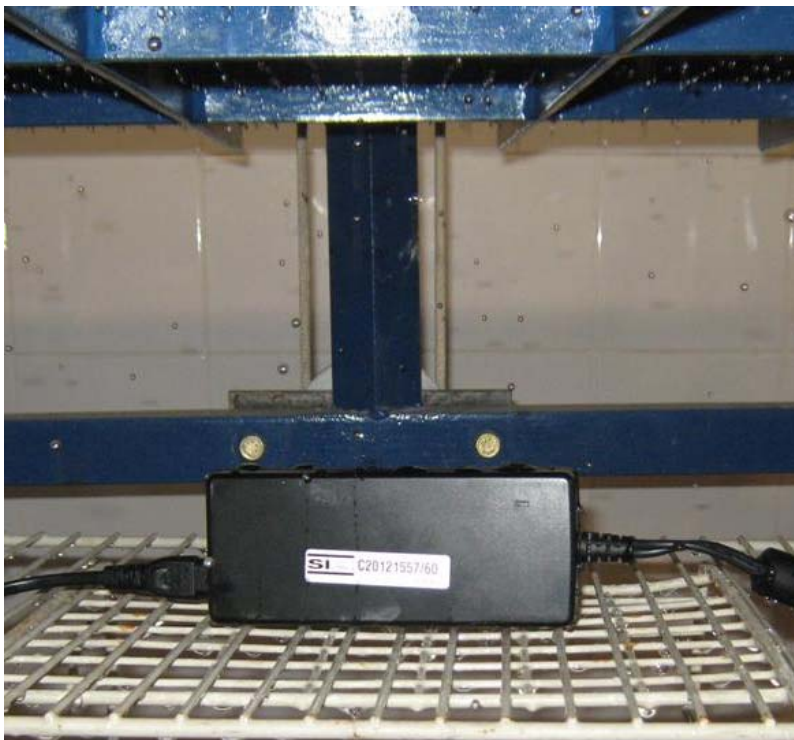
- Test device, drip box-as specified in standard,
- Water flow rate: 1 mm/min,
- The test sample was placed on the turntable under the drip box in most unfavourable normal position (Figure 3),
- Duration of the exposure: 10 minutes,

Figure 3: Test position

Conclusion: After the water test there was water on the connector pins.

Immediately following the water test the dielectric strength test with 4000 V a.c. has been conducted between primary and secondary terminals and between primary terminals and enclosure. The voltage was applied and maintained for a period of one minute between the points indicated. The test did NOT pass.
