# Poročilo o preskusu / Test Report

T211-0471/12

<b>Proizvod / Product</b> Power supply Model: GT-41083-WWV-X.X-T2 series Enclosure: TR9KE3300LCP-N(RV)	<b>Listov / Pages</b> 3
<b>Naročnik / Applicant</b> GlobTek, Inc 186 Veterans Dr, Northvale, NJ 07647 / USA	<b>Vrsta preskusa / Test procedure</b> IP40, IP41
<b>Proizvajalec / Manufacturer</b> GlobTek, Inc 186 Veterans Dr, Northvale, NJ 07647 / USA	<b>Št. Merjencev / No. of Items tested</b> 1
<b>Blagovna znamka / Trade Mark</b> GlobTek	<b>Mapa predmeta št. / Subject File No.</b> C20121557
<b>Standardi - predpisi / Standards - regulations</b> IEC 60529:2001	<b>Kraj preskusa / Place of test</b> SIQ - Slovenian Institute of Quality and Metrology, Tržaška 2, 1000 Ljubljana, Slovenia
	<b>Opomba / Remark</b> /

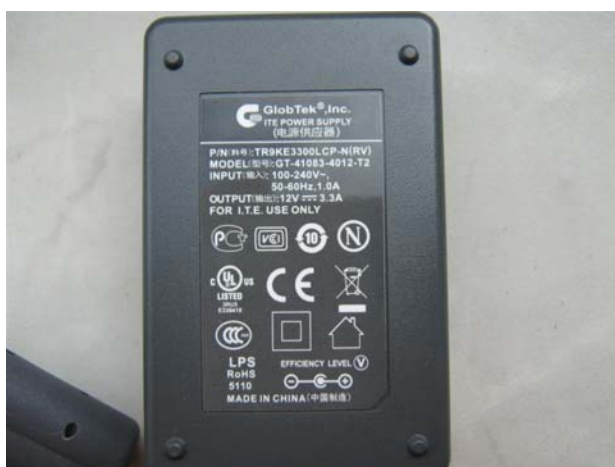
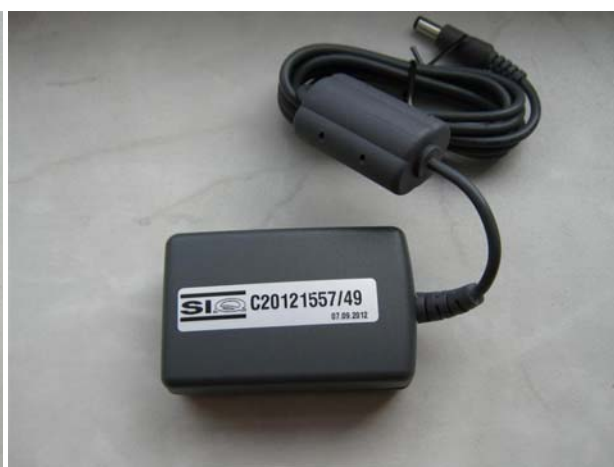
Power supply, model GT-41083-WWVV-X.X-T2 series, enclosure TR9KE3300LCP-N(RV) was subjected to testing for IP41 degree of protection (Figures 1 and 2).

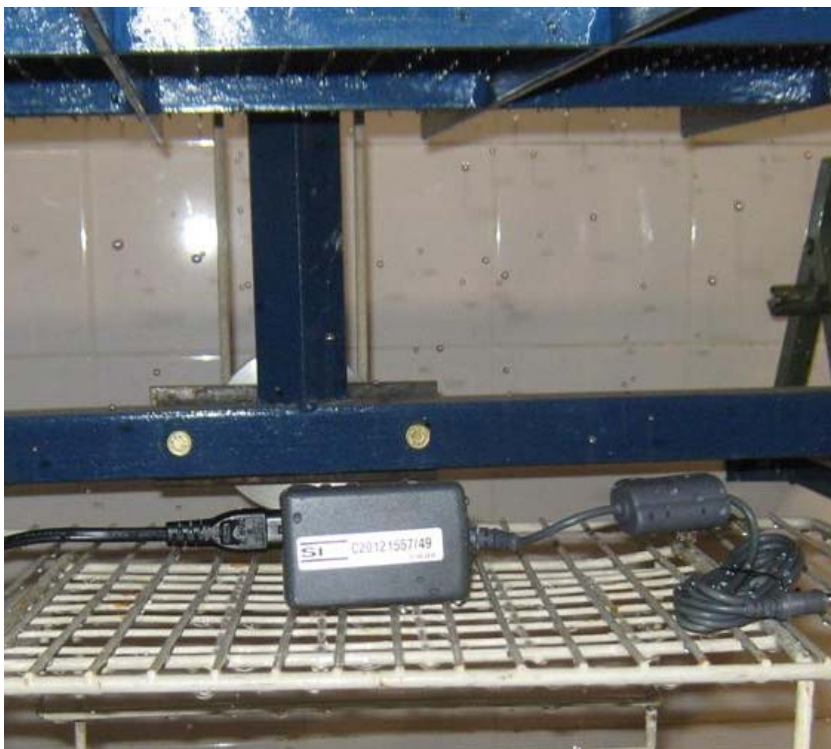
- Test device, drip box-as specified in standard,
- Water flow rate: 1 mm/min,
- The test sample was placed on the turntable under the drip box in most unfavourable normal position (Figure 3),
- Duration of the exposure: 10 minutes,

Figure 3: Test position

**Conclusion:** After the water test there was water on the connector pins.
