# Poročilo o preskusu / Test Report

T211-0462/12

Proizvod / Product	Listov / Pages
Power supply Model: GT-41130-WVVV-X.X-T2 series, GT-43006-WVVV-X.X-T2 series GT-41062-WVVV-X.X-T2 series, GT-41082-WVVV-X.X-T2 series Enclosure: TR9KE2000CCP-N(RV)	3
Naročnik / Applicant	Vrsta preskusa / Test procedure
GlobTek, Inc 186 Veterans Dr, Northvale, NJ 07647 / USA	IP40, IP41
Proizvajalec / Manufacturer	Št. Merjencev / No. of Items tested
GlobTek, Inc 186 Veterans Dr, Northvale, NJ 07647 / USA	1
Blagovna znamka / Trade Mark	Mapa predmeta št. / Subject File No.
GlobTek	C20121557
Standardi – predpisi / Standards - regulations	Kraj preskusa / Place of test
IEC 60529:2001	SIQ - Slovenian Institute of Quality and Metrology, Tržaška 2, 1000 Ljubljana, Slovenia
	Opomba / Remark
	/

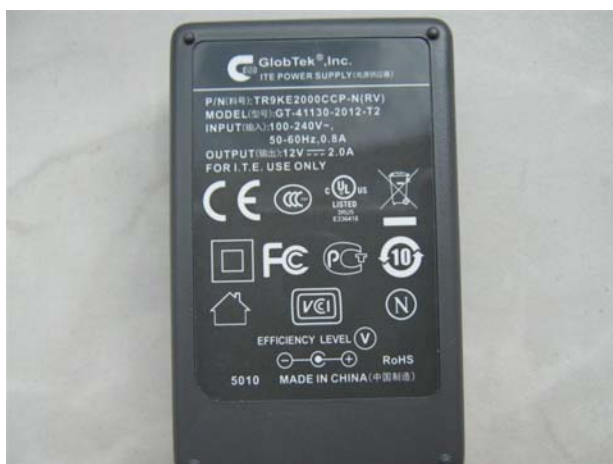
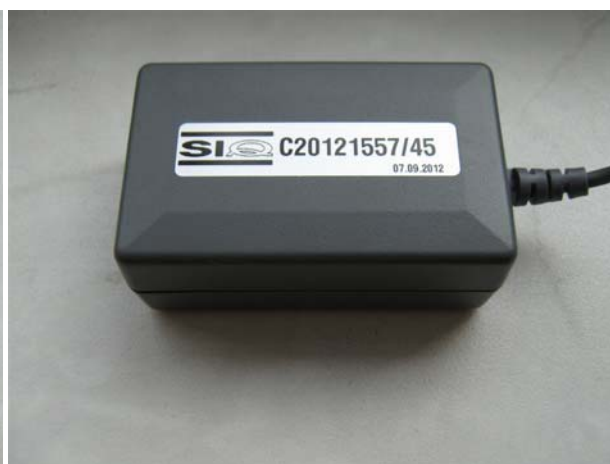
Figure 1

Power supply, model GT-41130-WWVV-X.X-T2 series, GT-43006-WWVV-X.X-T2 series, GT-41062-WWVV-X.X-T2 series and GT-41082-WWVV-X.X-T2 series, enclosure TR9KE2000CCP-N(RV) was subjected to testing for IP41 degree of protection (Figures 1 and 2).

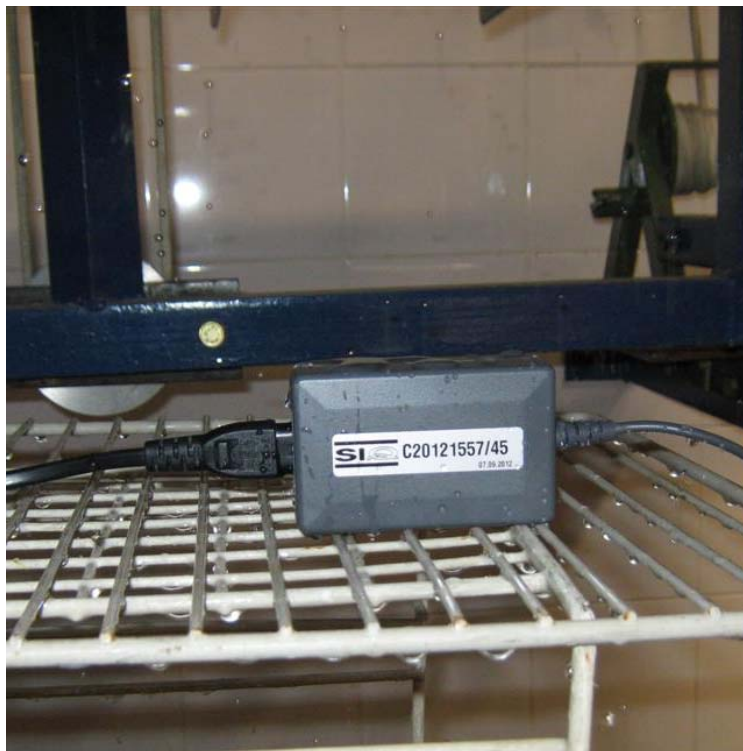
- Test device, drip box-as specified in standard,
- Water flow rate: 1 mm/min,
- The test sample was placed on the turntable under the drip box in most unfavourable normal position (Figure 3),
- Duration of the exposure: 10 minutes,

Figure 3: Test position

**Conclusion:** After the water test there was water on the connector pins.
