Slovenian Institute of
Quality and Metrology

Poročilo o preskusu / Test Report

T211-0464/12

Proizvod / Product	Listov / Pages
Power supply Model: GT-41132-WWVV-X.X-T3A series GT-43008-WWVV-X.X-T3A series Enclosure: TR9LE5000N05-N(RVB)	3
Naročnik / Applicant	Vrsta preskusa / Test procedure
GlobTek, Inc 186 Veterans Dr, Northvale, NJ 07647 / USA	IP40, IP41
Proizvajalec / Manufacturer	Št. Merjencev / No. of Items tested
GlobTek, Inc 186 Veterans Dr, Northvale, NJ 07647 / USA	1
Blagovna znamka / Trade Mark	Mapa predmeta št. / Subject File No.
GlobTek	C20121557
Standardi – predpisi / Standards - regulations	Kraj preskusa / Place of test
IEC 60529:2001	SIQ - Slovenian Institute of Quality and Metrology, Tržaška 2, 1000 Ljubljana, Slovenia
	Opomba / Remark
	/

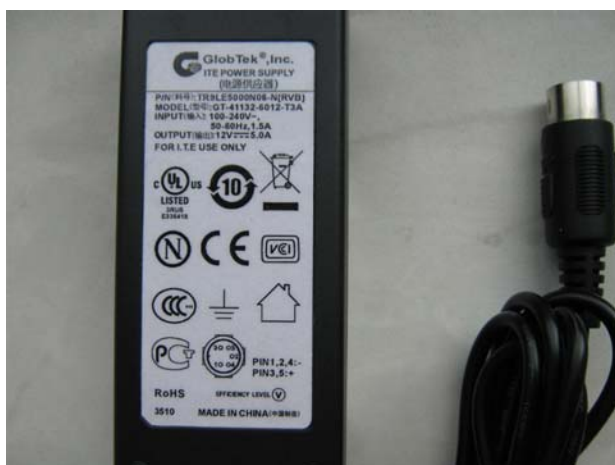
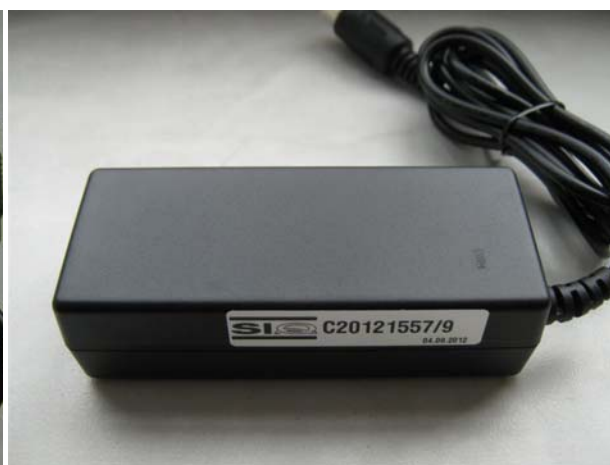
Figure 1

Power supply, model GT-41132-WWVV-X.X-T3A series and GT-43008-WWVV-X.X-T3A series, enclosure TR9LE5000N05-N(RVB) was subjected to testing for IP41 degree of protection (Figures 1 and 2).

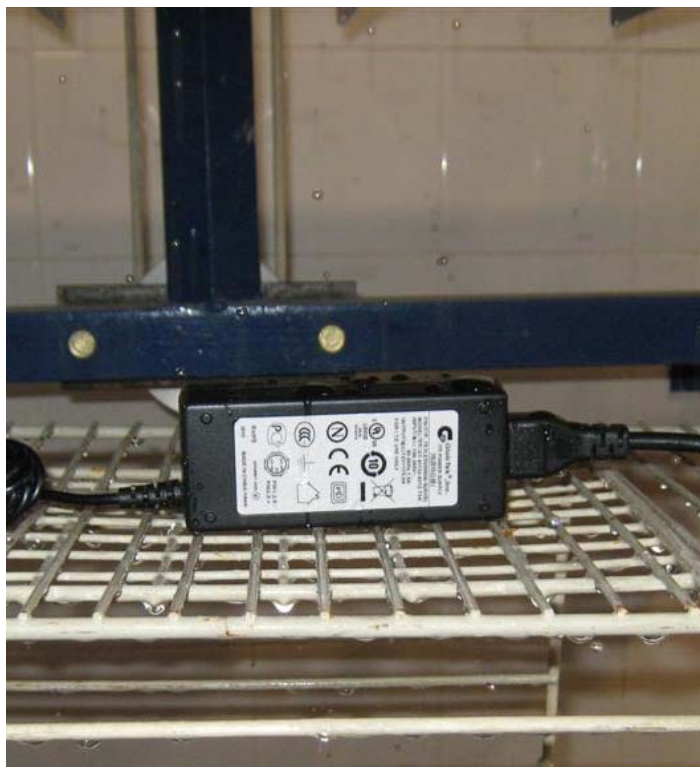
- Test device, drip box-as specified in standard,
- Water flow rate: 1 mm/min,
- The test sample was placed on the turntable under the drip box in most unfavourable normal position (Figure 3),
- Duration of the exposure: 10 minutes,

Figure 3: Test position

Conclusion: After the water test there was water on the connector pins.

- The rigid test wire was not penetrated into the enclosure
- After the IPX1 test there was water on connector pins.
- After the IPX1 test the dielectric strength test did NOT pass.
