Poročilo o preskusu / Test Report

T211-0057R/13

Proizvod / Product Power supply Model: GT-41060(GTM41060, GT-41131, GTM41131)	Listov / Pages 7
Naročnik / Applicant GlobTek, Inc 186 Veterans Dr, Northvale, NJ 07647 / USA	Vrsta preskusa / Test procedure IP52
Proizvajalec / Manufacturer GlobTek, Inc 186 Veterans Dr, Northvale, NJ 07647 / USA	Št. Merjencev / No. of Items tested 1
Blagovna znamka / Trade Mark GlobTek	Mapa predmeta št. / Subject File No. C20121856
Standardi – predpisi / Standards - regulations IEC 60529:2001	Kraj preskusa / Place of test SIQ - Slovenian Institute of Quality and Metrology, Tržaška 2, 1000 Ljubljana, Slovenia
	Opomba / Remark /

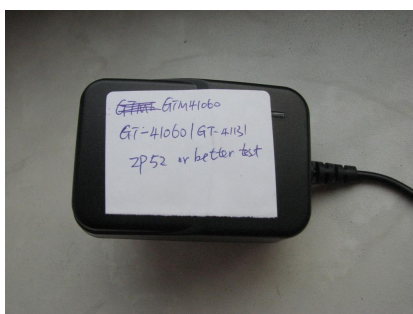
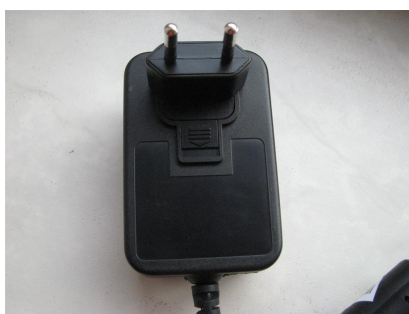
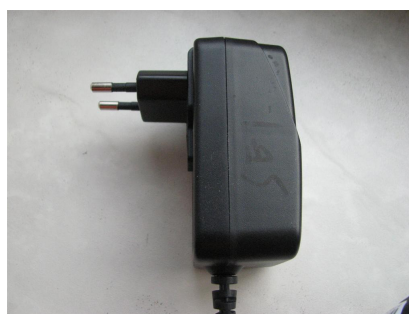
Power supply, model GT-41060(GTM41060, GT-41131, GTM41131) was subjected to testing for IP52 degree of protection (Figures 1 to 3).

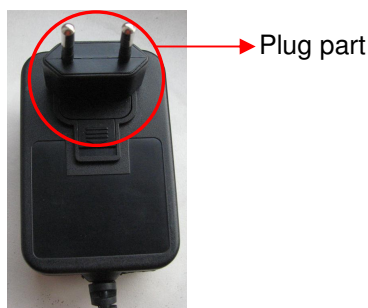
During the testing the power supply was connected to the socket outlet, see Figure 4. The plug part (Figure 5) with the socket outlet was not subject of the test. Test results do not relate to the whole power supply but only to the enclosure (without the plug part).

Figure 5: sample unit

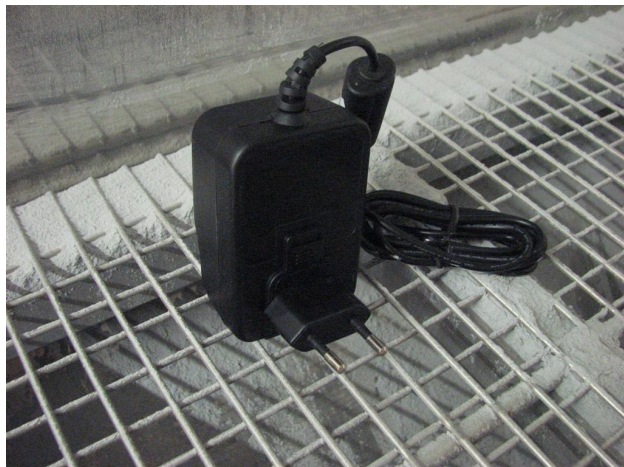
- Test chamber-as specified in standard,
- Dust, used for the test: talcum powder,
- Environmental temperature 24⁰C,
- No under pressure inside the enclosure,
- Duration of the exposure: 8 hours

Figure 6: EUT before the dust test

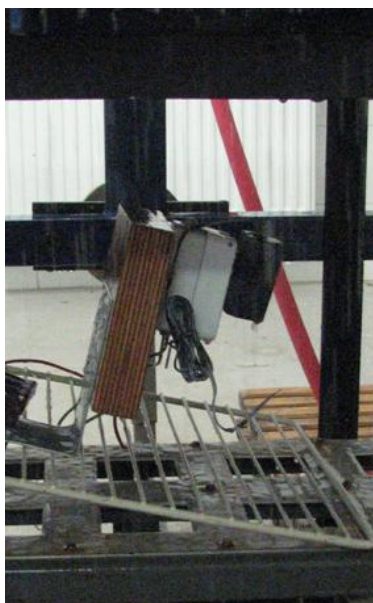
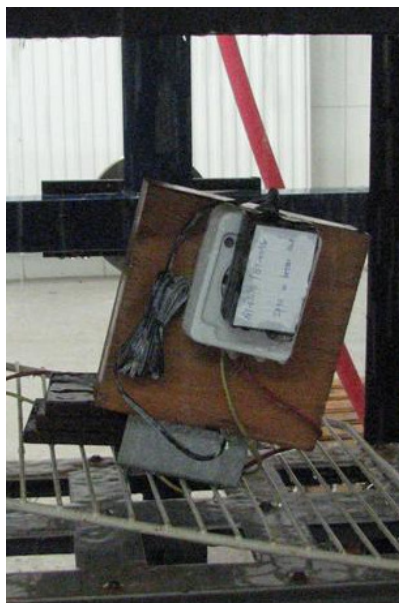
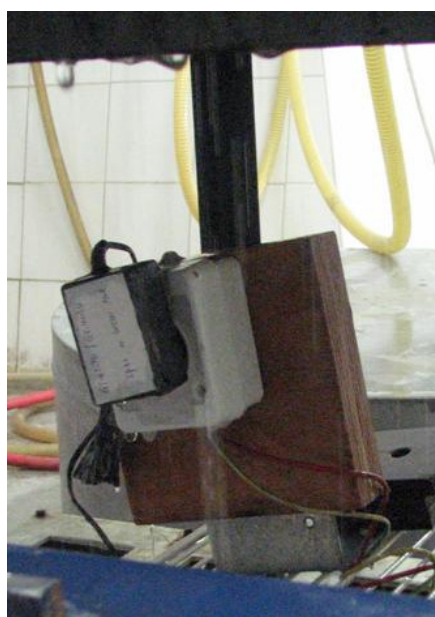
- Test device, drip box-as specified in standard,
- Water flow rate: 3 mm/min,
- The position of the test sample was fixed on 15⁰ on either side of the vertical in two mutually perpendicular planes,
- The test sample was tested for 2.5 minutes in each of four fixed positions (Figures 8 to 11),
- The total duration of the exposure was 10 minutes

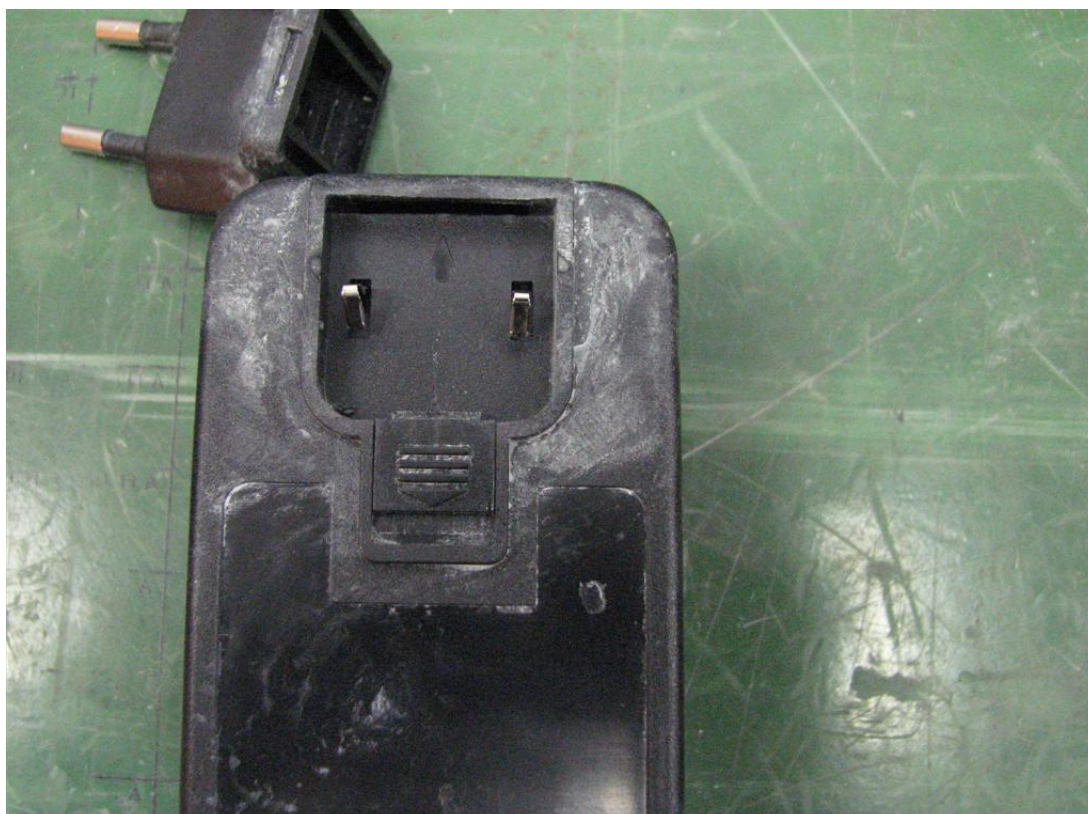
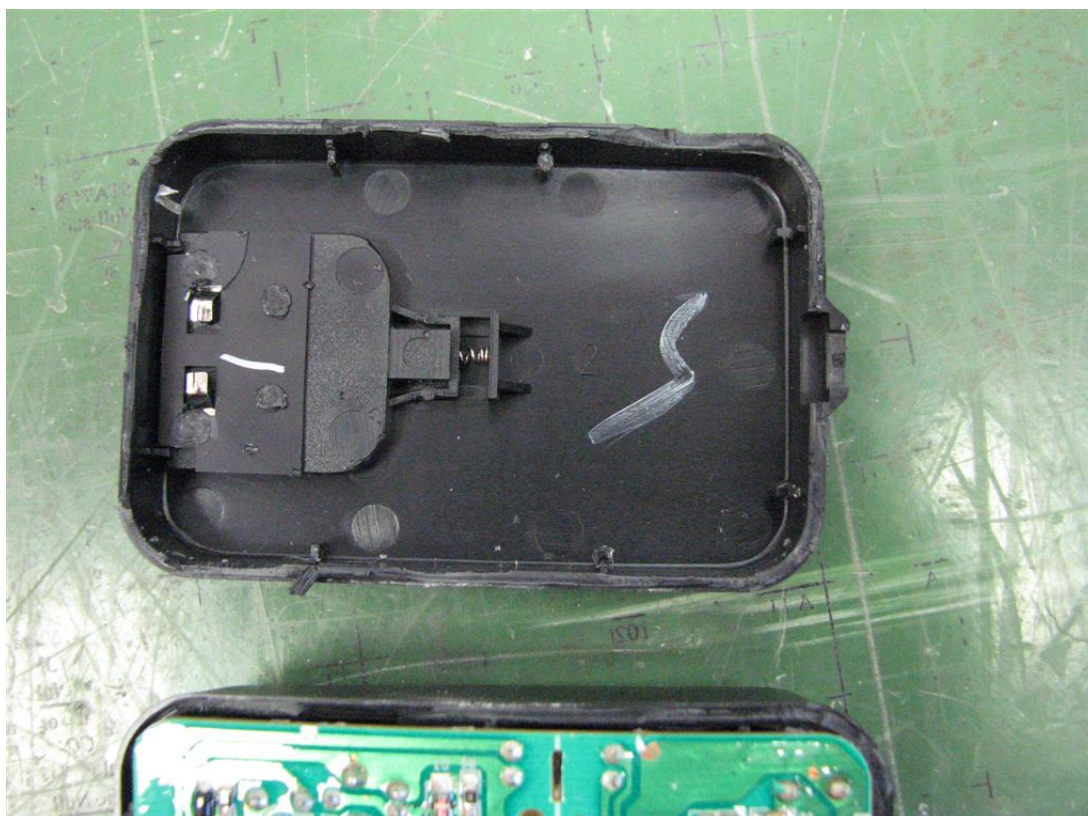
Conclusion: After the tests the enclosure was opened. There was no dust and no water inside the enclosure (Figures 12 to 16).

- There was no dust and no water inside the enclosure.
- There was no break down during the dielectric strength test.
