Poročilo o preskusu / Test Report

T211-0455/12

Proizvod / Product	Listov / Pages
Power supply Model: GT-41133-WWVV-X.X-T3 series GT-41069-WWVV-X.X-T3 series Enclosure: TR9CE7500CCP-N(RV)	3
Naročnik / Applicant	Vrsta preskusa / Test procedure
GlobTek, Inc 186 Veterans Dr, Northvale, NJ 07647 / USA	IP40, IP41
Proizvajalec / Manufacturer	Št. Merjencev / No. of Items tested
GlobTek, Inc 186 Veterans Dr, Northvale, NJ 07647 / USA	1
Blagovna znamka / Trade Mark	Mapa predmeta št. / Subject File No.
GlobTek	C20121557
Standardi – predpisi / Standards - regulations	Kraj preskusa / Place of test
IEC 60529:2001	SIQ - Slovenian Institute of Quality and Metrology, Tržaška 2, 1000 Ljubljana, Slovenia
	Opomba / Remark
	/

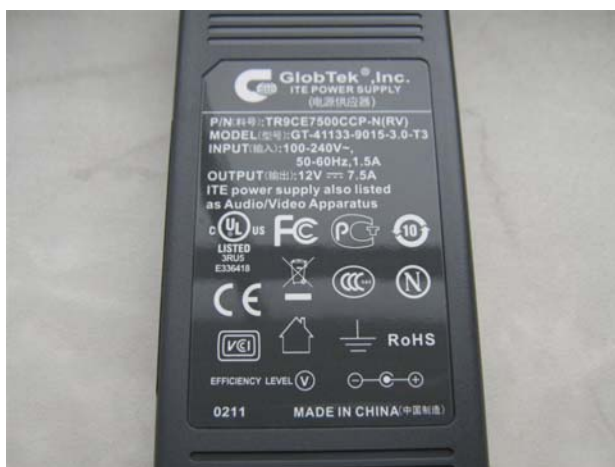
Figure 1

Power supply, model GT-41133-WWVV-X.X-T3 series and GT-41069-WWVV-X.X-T3 series, enclosure TR9CE7500CCP-N(RV) was subjected to testing for IP41 degree of protection (Figures 1 and 2).

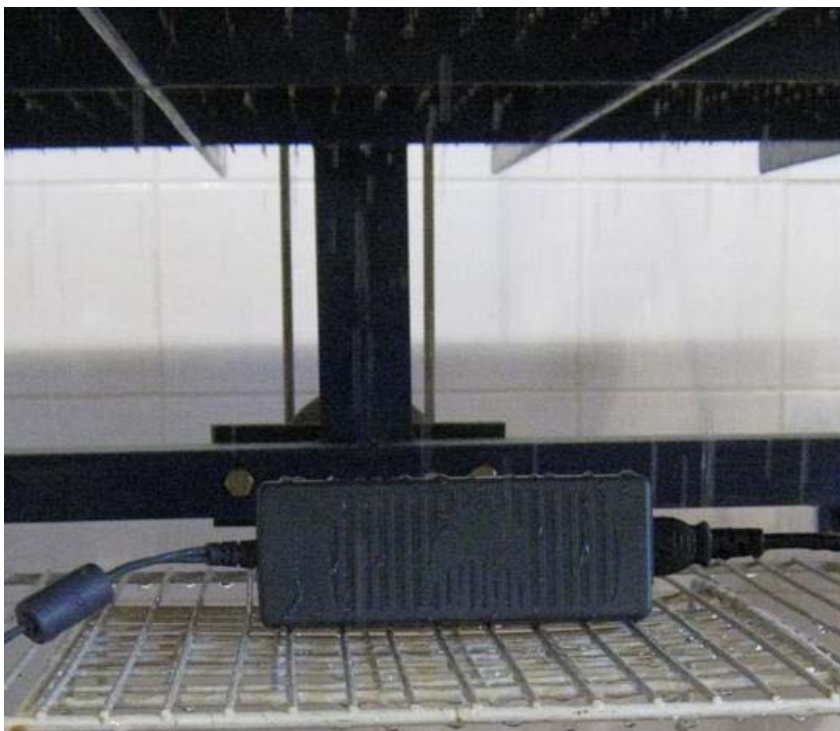
Figure 3: Test position

- Test device, drip box-as specified in standard,
- Water flow rate: 1 mm/min,
- The test sample was placed on the turntable under the drip box in most unfavourable normal position (Figure 3),
- Duration of the exposure: 10 minutes,

Conclusion: After the water test there was water on the connector pins.

Immediately following the water test the dielectric strength test with 4000 V a.c. has been conducted between primary and secondary terminals and between primary terminals and enclosure. The voltage was applied and maintained for a period of one minute between the points indicated. The test did NOT pass.
