Poročilo o preskusu / Test Report

T211-0483/12

Power supply

Model: GT-41134-0624

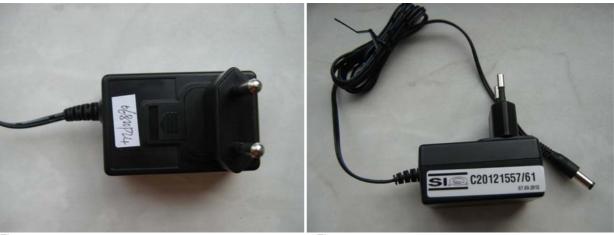
Figure 1 Figure 2

Power supply, model GT-41134-0624, was subjected to testing for IP41 degree of protection (Figures 1 and 2).

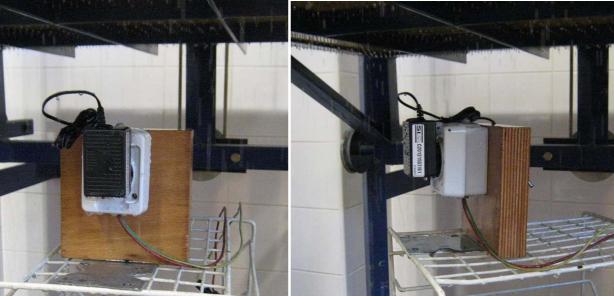
Figure 4: Test position

- Test device, drip box-as specified in standard,
- Water flow rate: 1 mm/min,
- The test sample was placed on the turntable under the drip box in most unfavourable normal position (Figures 4 and 5),
- Duration of the exposure: 10 minutes,

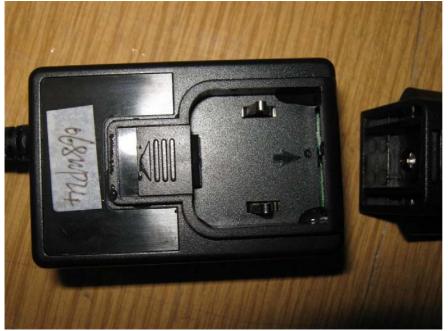
Figure 6

Conclusion: After the water test there was water on the appliance pins (Figure 6).

- The rigid test wire was not penetrated into the enclosure
- After the IPX1 test there was water on appliance pins.

Result: Following the acceptance conditions, the equipment under test sustained the test conditions for IP40 degree of protection.
