# Poročilo o preskusu / Test Report

T211-0474/12

| <b>Proizvod / Product</b><br>Power supply<br>Model: GT-81083-WVVV-X.X-W2Z series<br>GT-81088-WVVV-X.X-W2Z series<br>Enclosure: WR9HE417CCPFRVVBG2448 | <b>Listov / Pages</b><br>4 |

**Tested product complies with the requirements of stated standards for protection degree IP 41.**

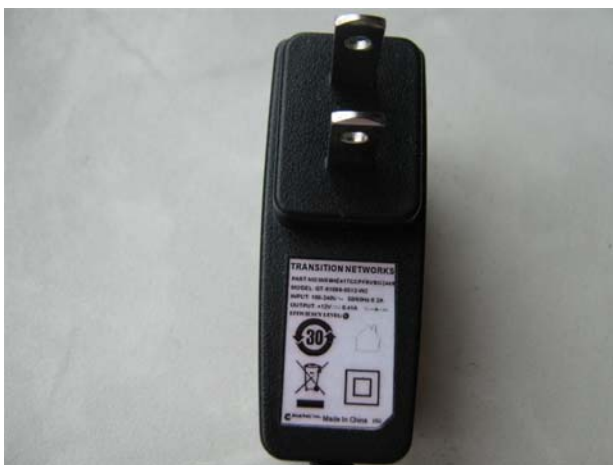
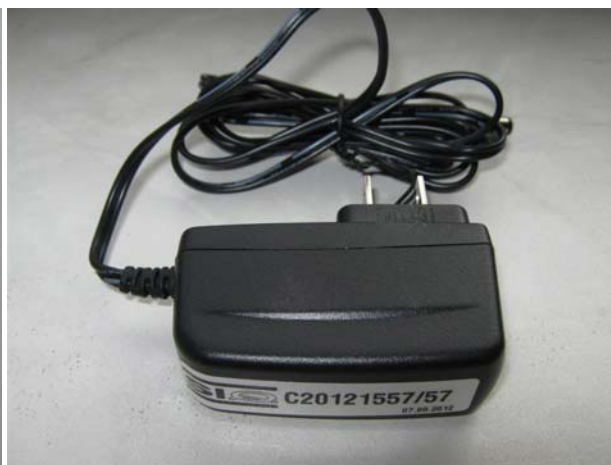
Power supply, model GT-81083-WWVV-X.X-W2Z series and GT-81088-WWVV-X.X-W2Z series, enclosure WR9HE417CCPFRVBG2448 was subjected to testing for IP41 degree of protection (Figures 1 and 2).

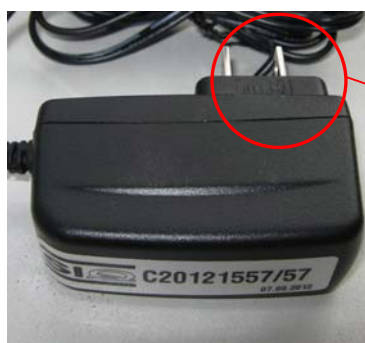
Figure 4: sample unit

During the testing the power supply was connected to the socket outlet, see Figure 3. The plug part (Figure 4) with the socket outlet was not subject of the test. Test results do not relate to the whole power supply but only to the enclosure (without the plug part).

Plug part

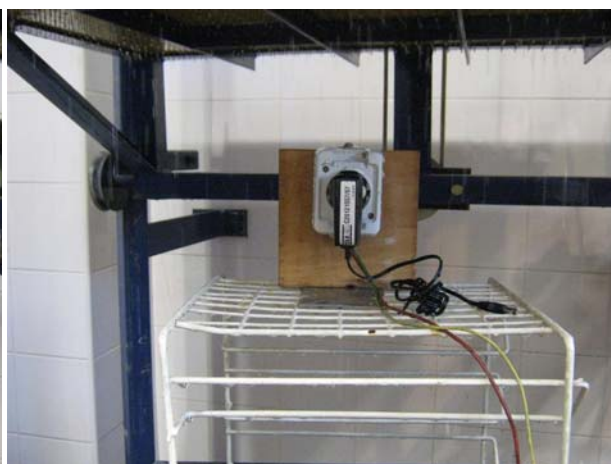
- Test device, drip box-as specified in standard,
- Water flow rate: 1 mm/min,
- The test sample was placed on the turntable under the drip box in most unfavorable normal position (Figures 5 and 6),
- Duration of the exposure: 10 minutes,

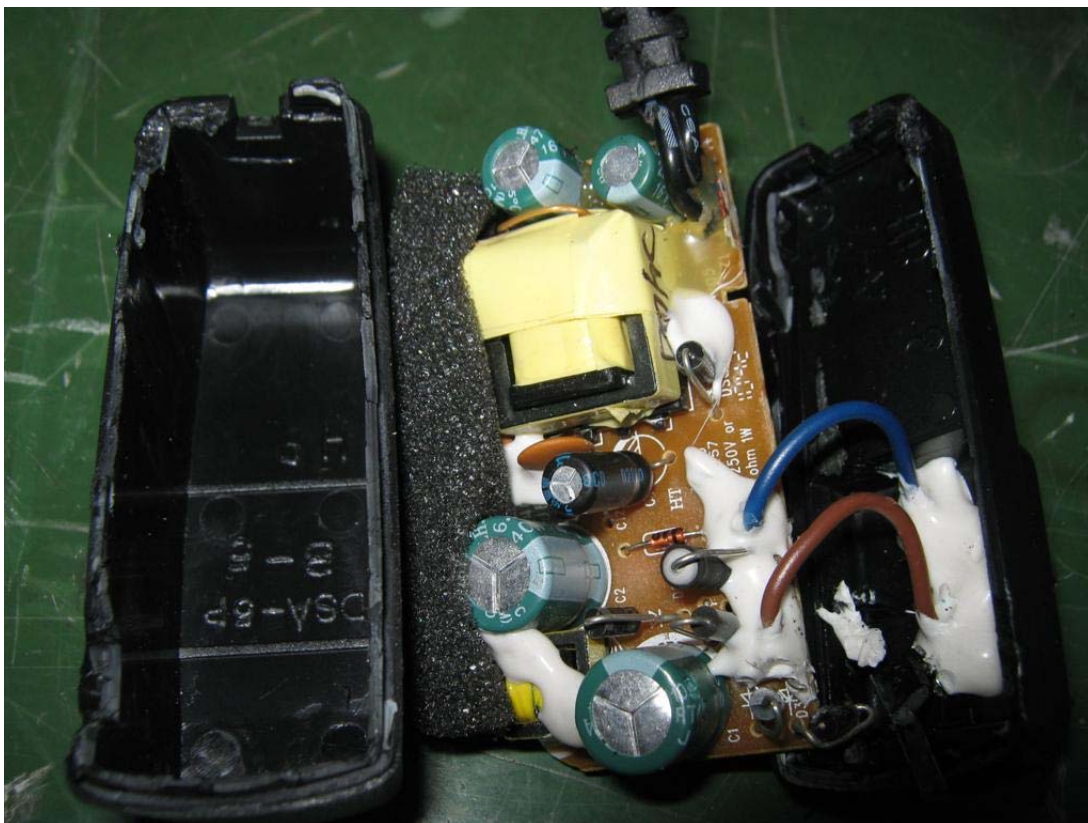
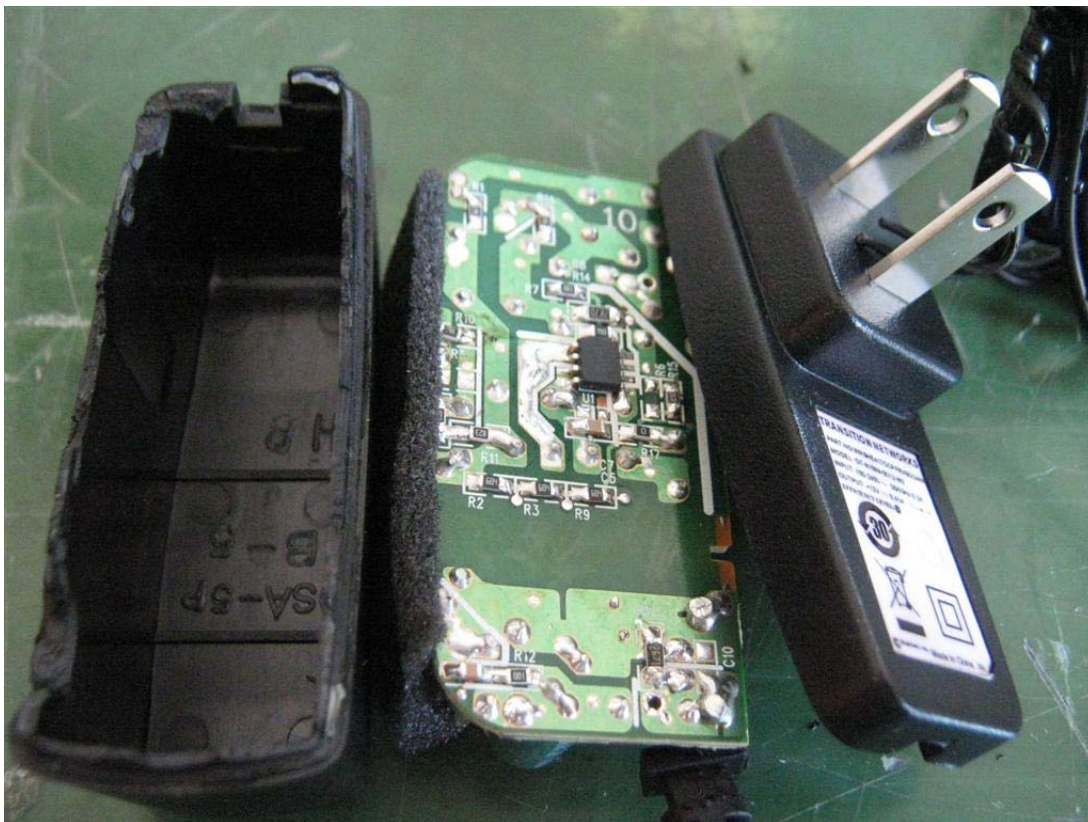
**Conclusion:** After the water test there was no water inside the enclosure (Figures 7 and 8).

- The rigid test wire was not penetrated into the enclosure
- After the IPX1 test there was NO water inside the enclosure.
