# Poročilo o preskusu / Test Report

T211-0473/12

<b>Proizvod / Product</b> Power supply Model: GT-81085-WVVV-X.X-WZZ series Enclosure: WR9HG1000KCP-N(RV)	<b>Listov / Pages</b> 4
<b>Naročnik / Applicant</b> GlobTek, Inc 186 Veterans Dr, Northvale, NJ 07647 / USA	<b>Vrsta preskusa / Test procedure</b> IP41
<b>Proizvajalec / Manufacturer</b> GlobTek, Inc 186 Veterans Dr, Northvale, NJ 07647 / USA	<b>Št. Merjencev / No. of Items tested</b> 1
<b>Blagovna znamka / Trade Mark</b> GlobTek	<b>Mapa predmeta št. / Subject File No.</b> C20121557
<b>Standardi – predpisi / Standards - regulations</b> IEC 60529:2001	<b>Kraj preskusa / Place of test</b> SIQ - Slovenian Institute of Quality and Metrology, Tržaška 2, 1000 Ljubljana, Slovenia
	<b>Opomba / Remark</b> /

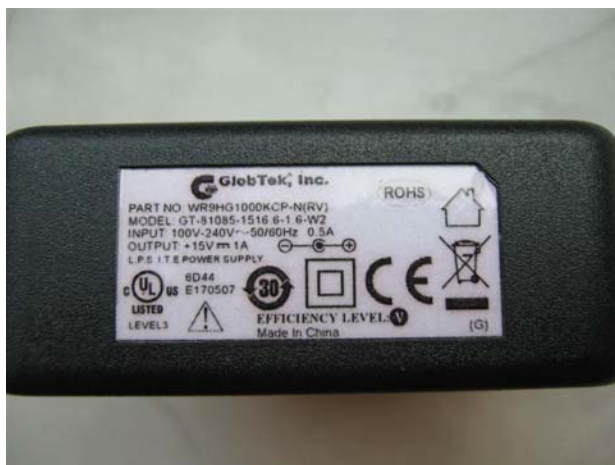
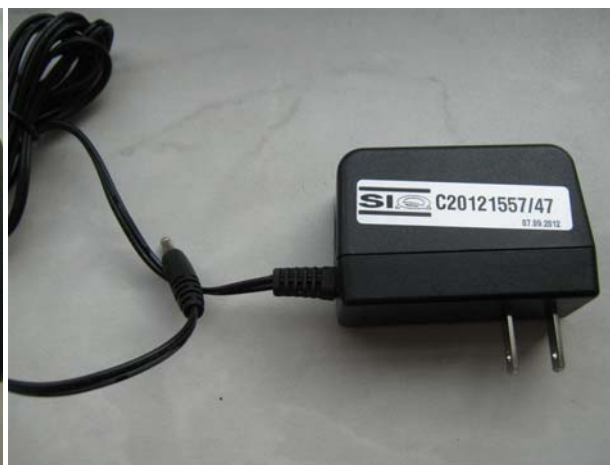
Power supply, model GT-81085-WWVV-X.X-W2Z series, enclosure WR9HG1000KCP-N(RV) was subjected to testing for IP41 degree of protection (Figures 1 and 2).

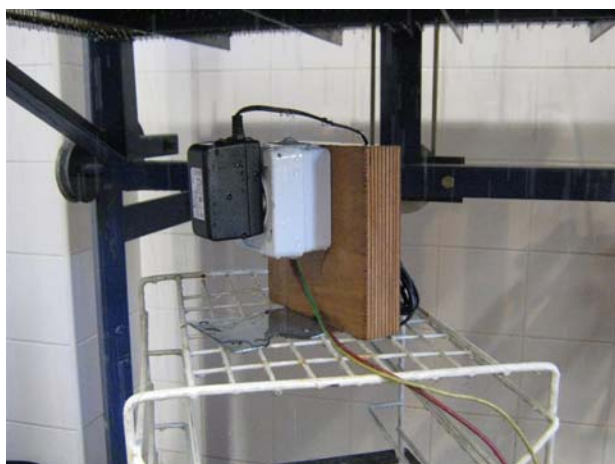
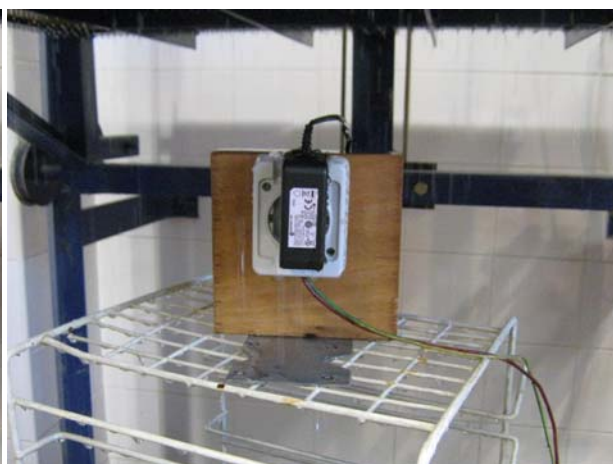
- Test device, drip box-as specified in standard,
- Water flow rate: 1 mm/min,
- The test sample was placed on the turntable under the drip box in most unfavorable normal position (Figures 5 and 6),
- Duration of the exposure: 10 minutes,

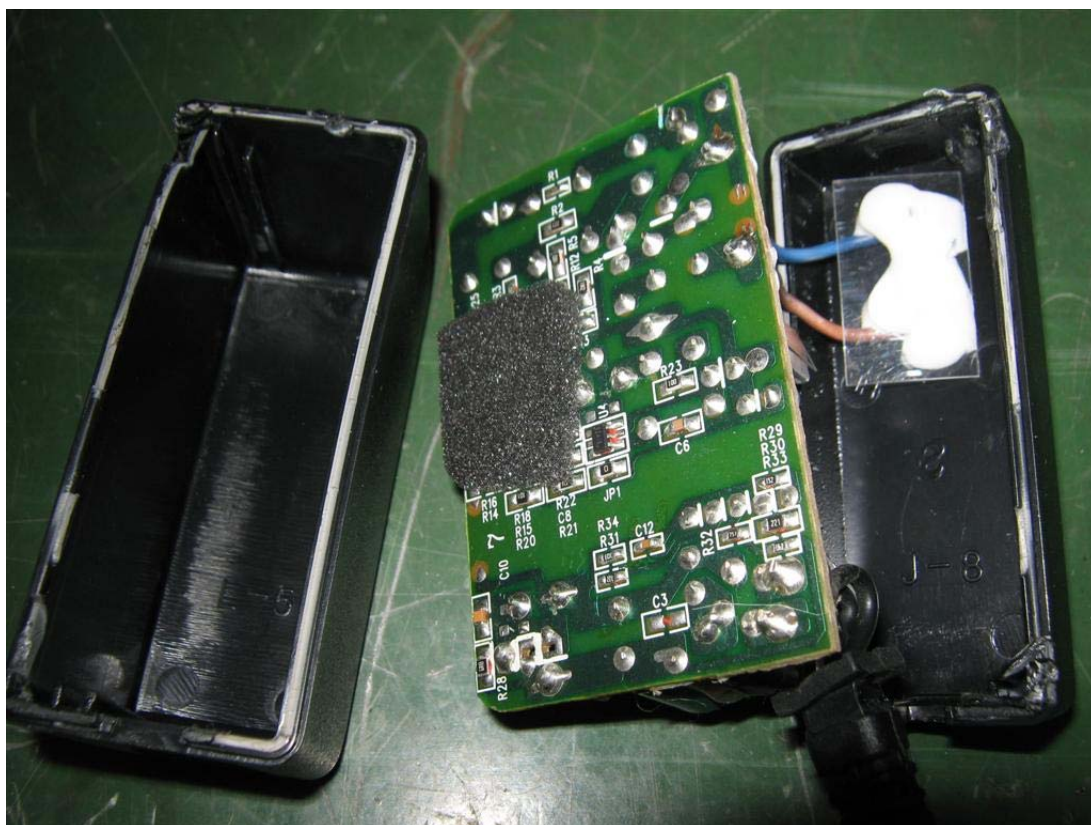
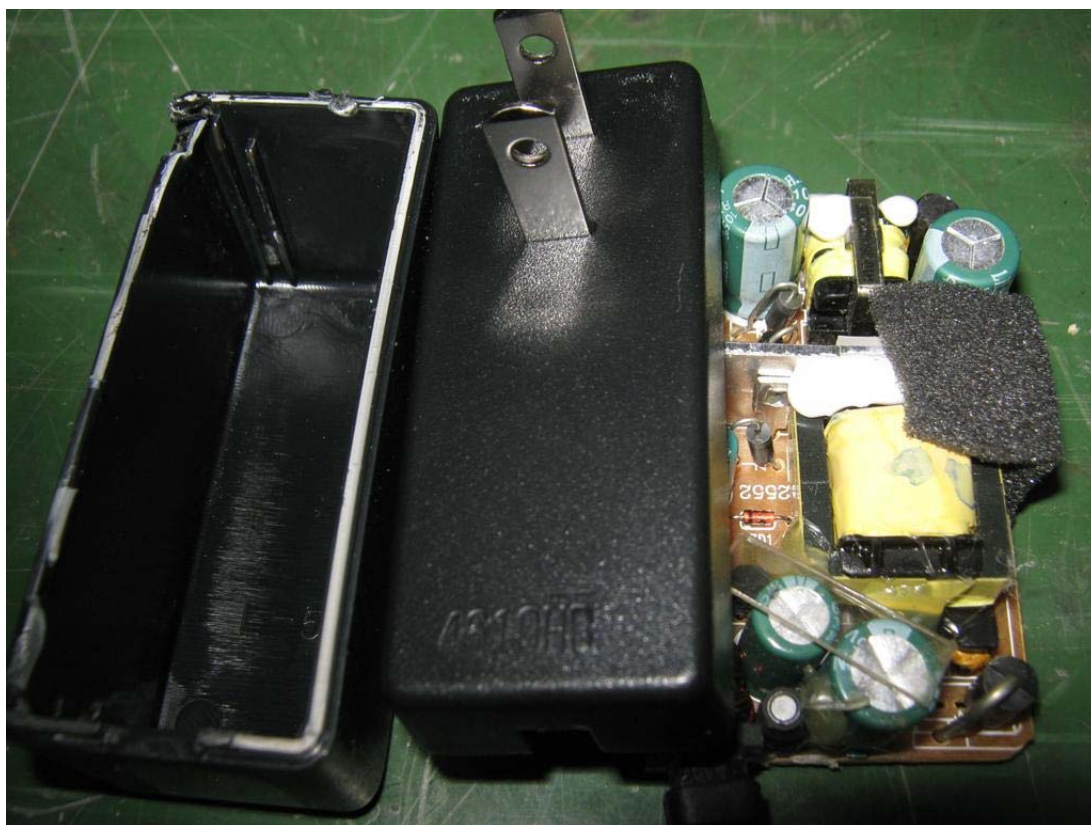
**Conclusion:** After the water test there was no water inside the enclosure (Figures 7 and 8).

- The rigid test wire was not penetrated into the enclosure
- After the IPX1 test there was NO water inside the enclosure.
