Slovenski institut za
kakovost in meroslovje

Poročilo o preskusu / Test Report

T211-0474/12

Proizvod / Product Power supply Model: GT-81083-WVVV-X.X-W2Z series GT-81088-WVVV-X.X-W2Z series Enclosure: WR9HE417CCPFRVBG2448	Listov / Pages 4
Naročnik / Applicant GlobTek, Inc 186 Veterans Dr, Northvale, NJ 07647 / USA	Vrsta preskusa / Test procedure IP41
Proizvajalec / Manufacturer GlobTek, Inc 186 Veterans Dr, Northvale, NJ 07647 / USA	Št. Merjencev / No. of Items tested 1
Blagovna znamka / Trade Mark GlobTek	Mapa predmeta št. / Subject File No. C20121557
Standardi – predpisi / Standards – regulations IEC 60529:2001	Kraj preskusa / Place of test SIQ - Slovenian Institute of Quality and Metrology, Tržaška 2, 1000 Ljubljana, Slovenia
	Opomba / Remark /

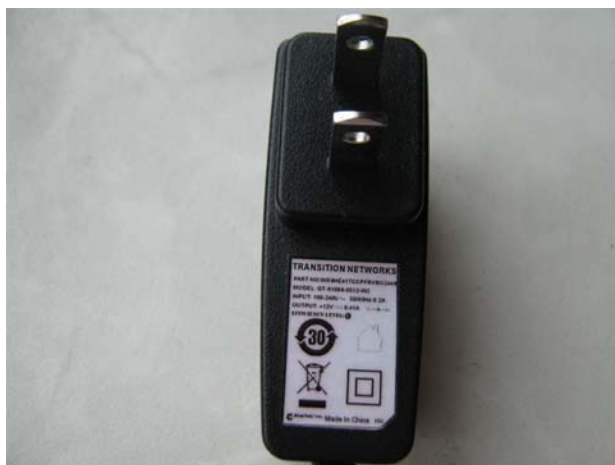
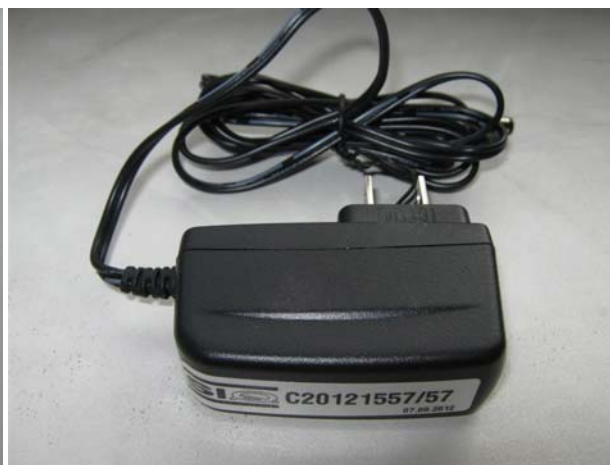
Power supply, model GT-81083-WWVV-X.X-W2Z series and GT-81088-WWVV-X.X-W2Z series, enclosure WR9HE417CCPFRVBG2448 was subjected to testing for IP41 degree of protection (Figures 1 and 2).

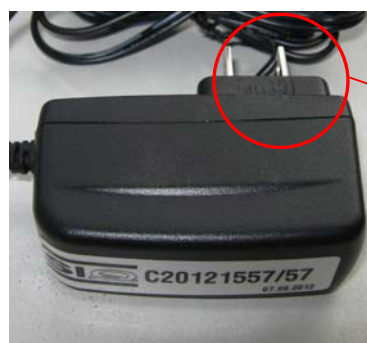
Figure 4: sample unit

During the testing the power supply was connected to the socket outlet, see Figure 3. The plug part (Figure 4) with the socket outlet was not subject of the test. Test results do not relate to the whole power supply but only to the enclosure (without the plug part).

Plug part

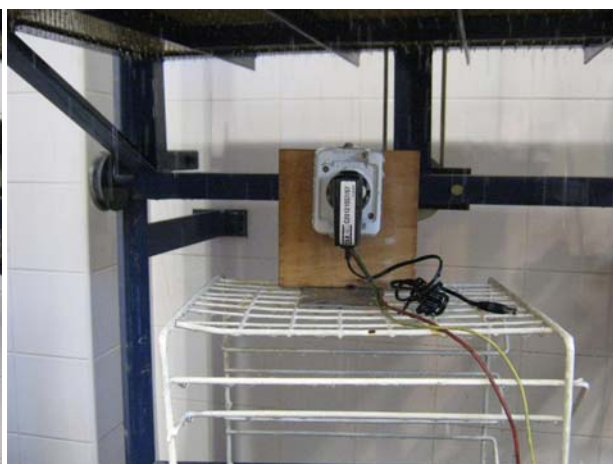
- Test device, drip box-as specified in standard,
- Water flow rate: 1 mm/min,
- The test sample was placed on the turntable under the drip box in most unfavorable normal position (Figures 5 and 6),
- Duration of the exposure: 10 minutes,

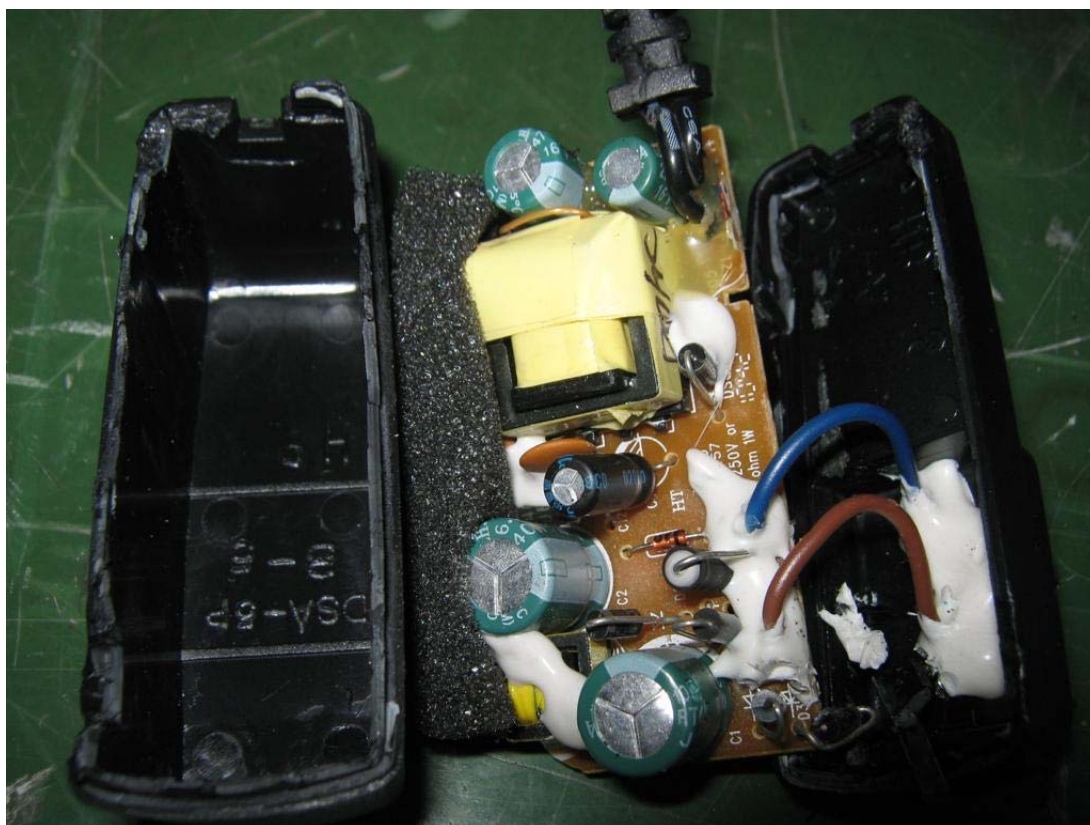
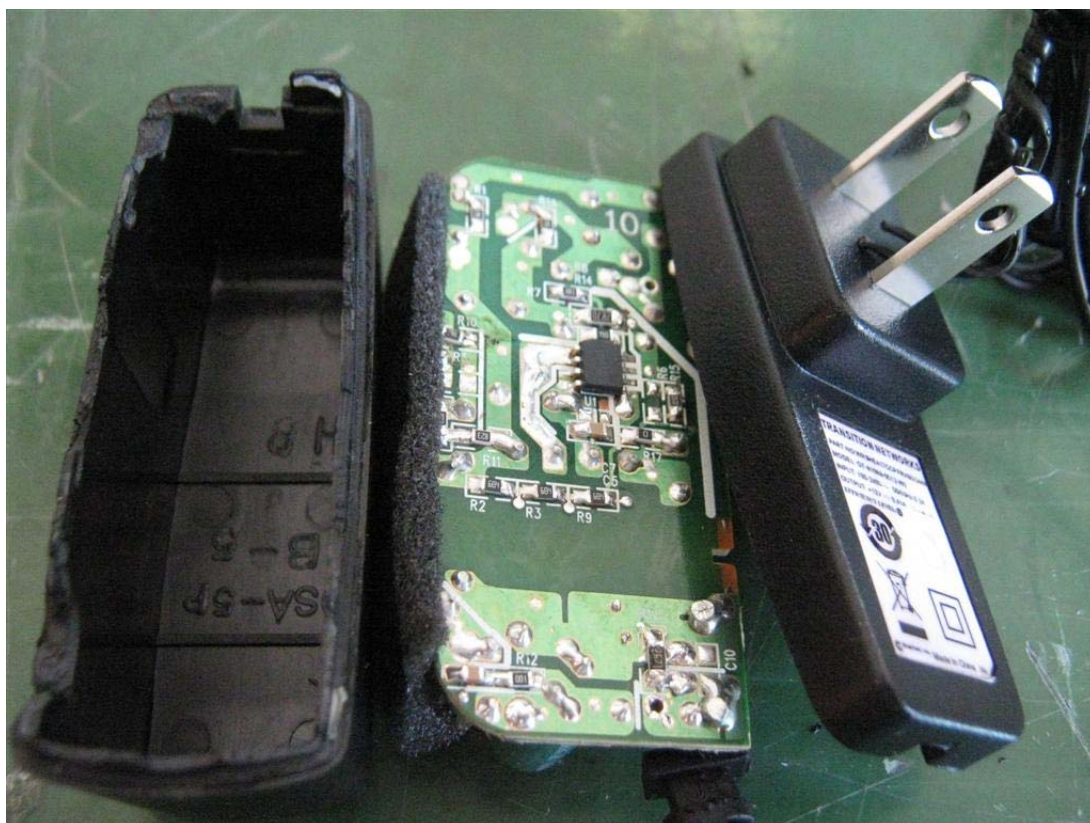
Conclusion: After the water test there was no water inside the enclosure (Figures 7 and 8).

- The rigid test wire was not penetrated into the enclosure
- After the IPX1 test there was NO water inside the enclosure.
