Poročilo o preskusu / Test Report

T211-0458/12

Proizvod / Product Power supply Model: GT-81081-WVVV-X.X-T2 series GT-81091-WVVV-X.X-T2 series Enclosure: TR9KE5000LCP-F(R)	Listov / Pages 4
Naročnik / Applicant GlobTek, Inc 186 Veterans Dr, Northvale, NJ 07647 / USA	Vrsta preskusa / Test procedure IP41
Proizvajalec / Manufacturer GlobTek, Inc 186 Veterans Dr, Northvale, NJ 07647 / USA	Št. Merjencev / No. of Items tested 1
Blagovna znamka / Trade Mark GlobTek	Mapa predmeta št. / Subject File No. C20121557
Standardi – predpisi / Standards - regulations IEC 60529:2001	Kraj preskusa / Place of test SIQ - Slovenian Institute of Quality and Metrology, Tržaška 2, 1000 Ljubljana, Slovenia
	Opomba / Remark /

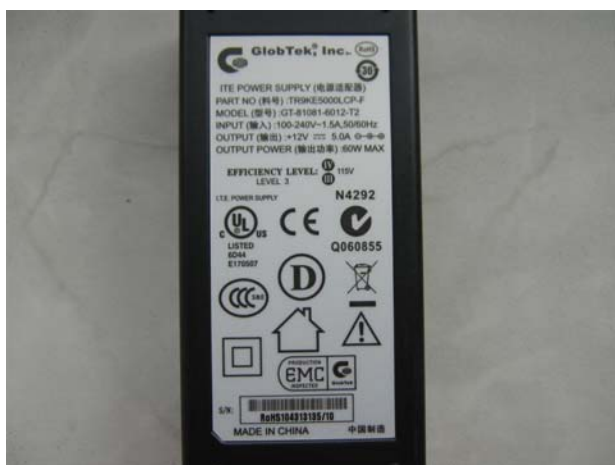
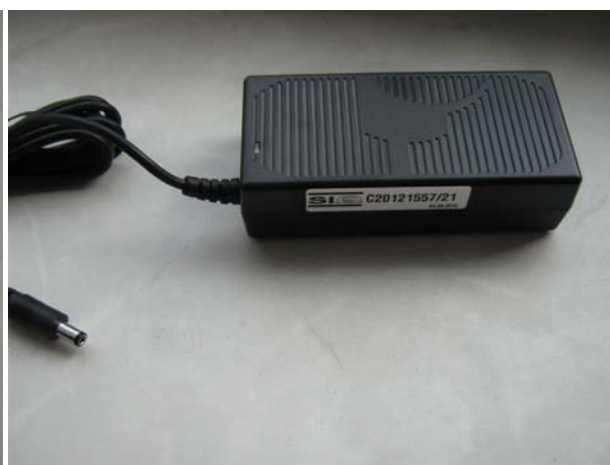
Figure 1

Power supply, model GT-81081-WWVV-X.X-T2 series and GT-81091-WWVV-X.X-T2 series, enclosure TR9KE5000LCP-F(R) was subjected to testing for IP41 degree of protection (Figures 1 and 2).

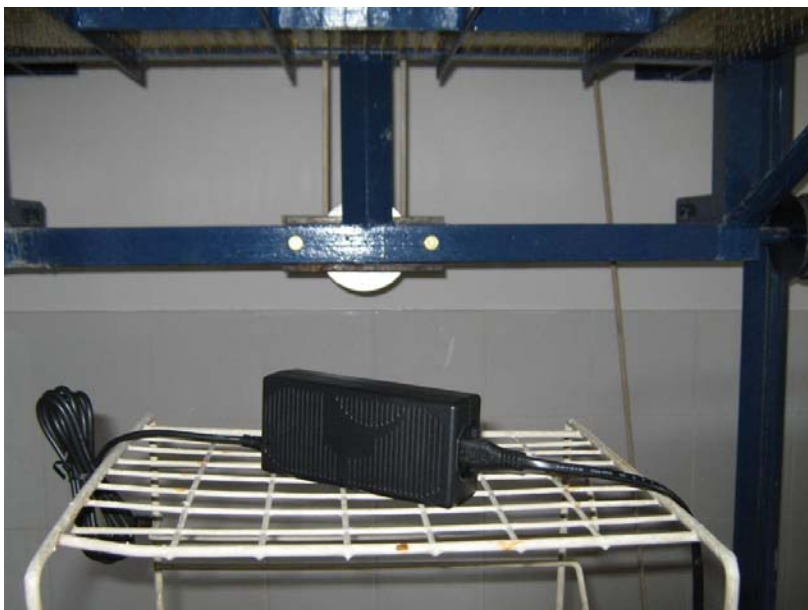
- Test device, drip box-as specified in standard,
- Water flow rate: 1 mm/min,
- The test sample was placed on the turntable under the drip box in most unfavourable normal position (Figure 3),
- Duration of the exposure: 10 minutes,

Figure 3: Test position

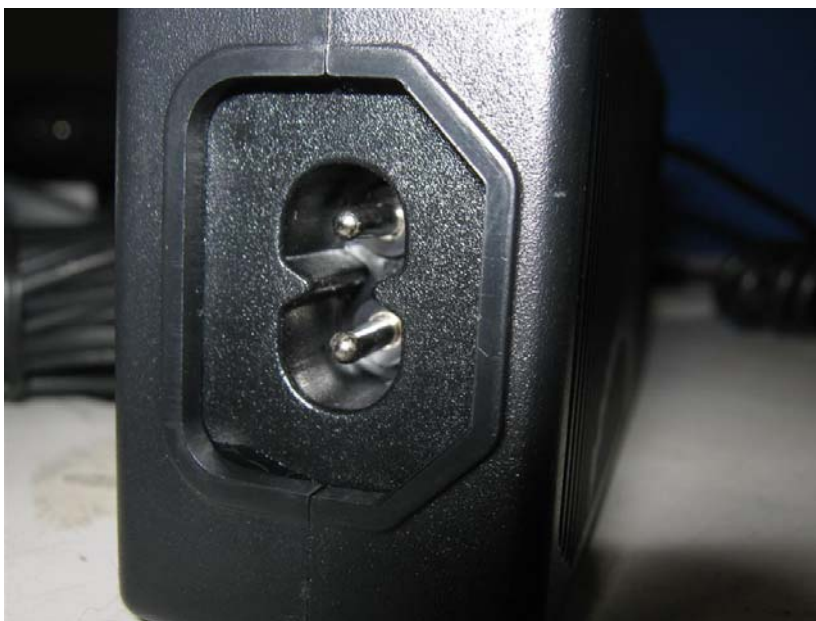
Figure 4

Conclusion: After the water test there was no water on the connector pins (Figure 4).

- The rigid test wire was not penetrated into the enclosure
- After the IPX1 test there was no water on connector pins.
- After the IPX1 test the sample successfully passed the dielectric strength test.
