# Poročilo o preskusu / Test Report

T211-0456/12

<b>Proizvod / Product</b> Power supply Model: GT-81081-WWVV-X.X-T3 series, GT-81091-WWVV-X.X-T3 series GT-81081-WWVV-X.X-T3A series, GT-81091-WWVV-X.X-T3A series Enclosure: TR9CE5000Q00-F(R)	<b>Listov / Pages</b> 3
<b>Naročnik / Applicant</b> GlobTek, Inc 186 Veterans Dr, Northvale, NJ 07647 / USA	<b>Vrsta preskusa / Test procedure</b> IP40, IP41
<b>Proizvajalec / Manufacturer</b> GlobTek, Inc 186 Veterans Dr, Northvale, NJ 07647 / USA	<b>Št. Merjencev / No. of Items tested</b> 1
<b>Blagovna znamka / Trade Mark</b> GlobTek	<b>Mapa predmeta št. / Subject File No.</b> C20121557
<b>Standardi – predpisi / Standards - regulations</b> IEC 60529:2001	<b>Kraj preskusa / Place of test</b> SIQ - Slovenian Institute of Quality and Metrology, Tržaška 2, 1000 Ljubljana, Slovenia
	<b>Opomba / Remark</b> /

**Tested product complies with the requirements of stated standards for protection degree IP 40.**

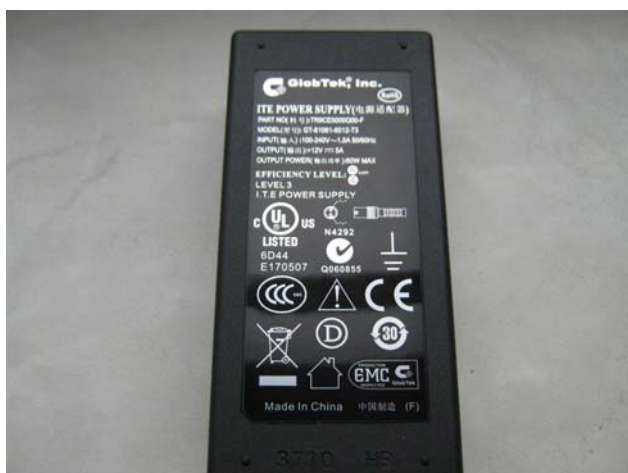
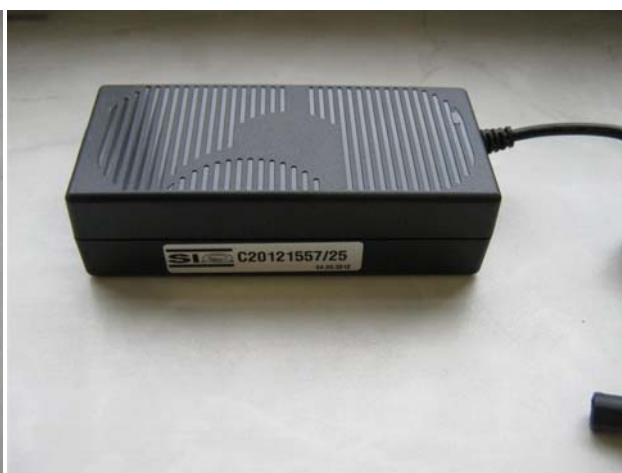
Figure 1

Power supply, model GT-81081-WWVV-X.X-T3 series, GT-81091-WWVV-X.X-T3 series, GT-81081-WWVV-X.X-T3A series and GT-81091-WWVV-X.X-T3A series, enclosure TR9CE5000Q00-F(R) was subjected to testing for IP41 degree of protection (Figures 1 and 2).

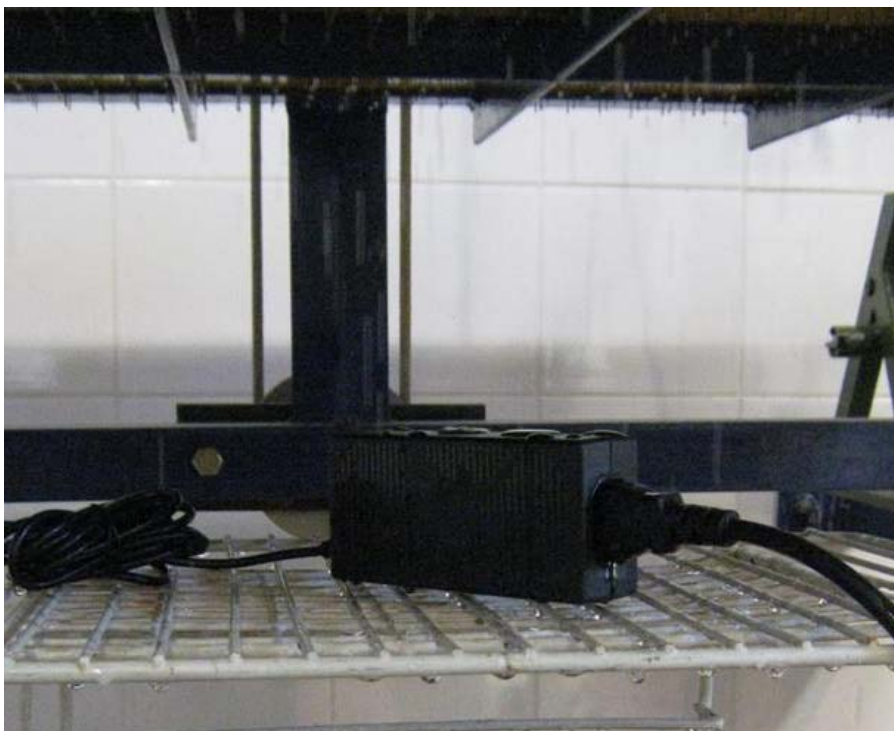
- Test device, drip box-as specified in standard,
- Water flow rate: 1 mm/min,
- The test sample was placed on the turntable under the drip box in most unfavourable normal position (Figure 3),
- Duration of the exposure: 10 minutes,

Figure 3: Test position

**Conclusion:** After the water test there was water on the connector pins.

Immediately following the water test the dielectric strength test with 4000 V a.c. has been conducted between primary and secondary terminals and between primary terminals and enclosure. The voltage was applied and maintained for a period of one minute between the points indicated. The test did NOT pass.

- The rigid test wire was not penetrated into the enclosure
- After the IPX1 test there was water on connector pins.
- After the IPX1 test the dielectric strength test did NOT pass.

**Result:** Following the acceptance conditions, the equipment under test sustained the test conditions for IP40 degree of protection.
