Poročilo o preskusu / Test Report

T211-0465/12

Proizvod / Product	Listov / Pages
Power supply Model: GTM91120-WVVV-X.X-T3A series GT-91120-WVVV-X.X-T3A series Enclosure: RR9LA4000CCPYIM(RVB)	3
Naročnik / Applicant	Vrsta preskusa / Test procedure
GlobTek, Inc 186 Veterans Dr, Northvale, NJ 07647 / USA	IP40, IP41
Proizvajalec / Manufacturer	Št. Merjencev / No. of Items tested
GlobTek, Inc 186 Veterans Dr, Northvale, NJ 07647 / USA	1
Blagovna znamka / Trade Mark	Mapa predmeta št. / Subject File No.
GlobTek	C20121557
Standardi – predpisi / Standards – regulations	Kraj preskusa / Place of test
IEC 60529:2001	SIQ - Slovenian Institute of Quality and Metrology, Tržaška 2, 1000 Ljubljana, Slovenia
	Opomba / Remark
	/

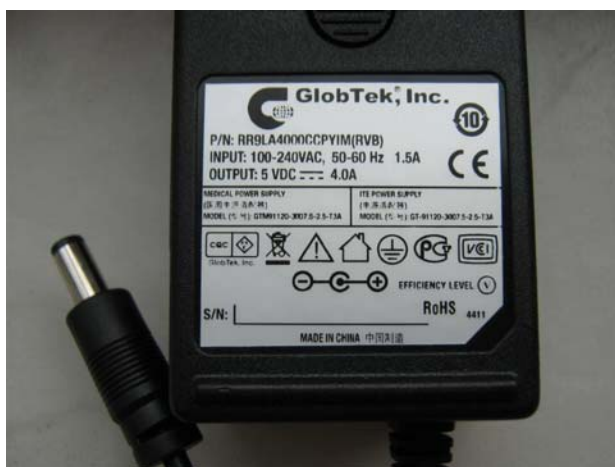
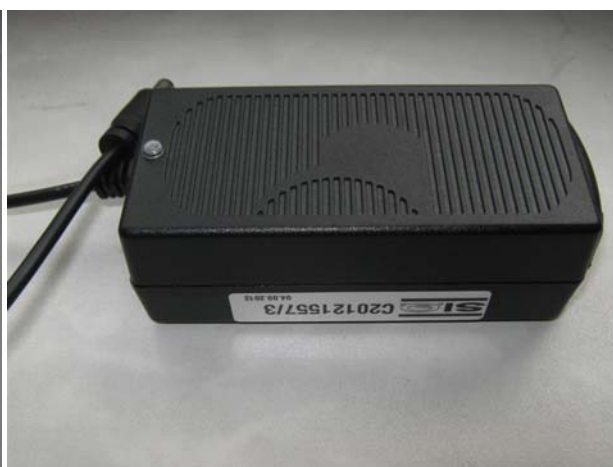
Figure 1

Power supply, model GTM91120-WWVV-X.X-T3A series and GT-91120-WWVV-X.X-T3A series, enclosure RR9LA4000CCPYIM(RVB) was subjected to testing for IP41 degree of protection (Figures 1 and 2).
