Poročilo o preskusu / Test Report

T211-0686R/12

Proizvod / Product	Listov / Pages
Power supply Model: GT-41052-1548 GT-41080, GT-41081, GTM41076, GTM41134, GT-43007, GT-41062, GT-41135, GTM41080, GTM41081	6
Naročnik / Applicant	Vrsta preskusa / Test procedure
GlobTek, Inc 186 Veterans Dr, Northvale, NJ 07647 / USA	IP52
Proizvajalec / Manufacturer	Št. Merjencev / No. of Items tested
GlobTek, Inc 186 Veterans Dr, Northvale, NJ 07647 / USA	1
Blagovna znamka / Trade Mark	Mapa predmeta št. / Subject File No.
GlobTek	C20121557
Standardi – predpisi / Standards - regulations	Kraj preskusa / Place of test
IEC 60529:2001	SIQ - Slovenian Institute of Quality and Metrology, Tržaška 2, 1000 Ljubljana, Slovenia
	Opomba / Remark
	/

Tested product complies with the requirements of stated standards for protection degree IP 52.

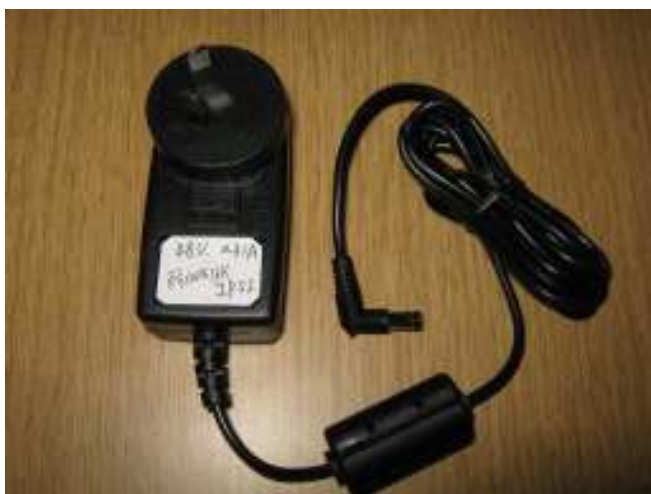
Figure 1

Power supply, model GT-41052-1548 was subjected to testing for IP52 degree of protection (Figure 1). Models GT-41080, GT-41081, GTM41076, GTM41134, GT-43007, GT-41062, GT-41135, GTM41080 and GTM41081 have the same enclosure as GT-41052.

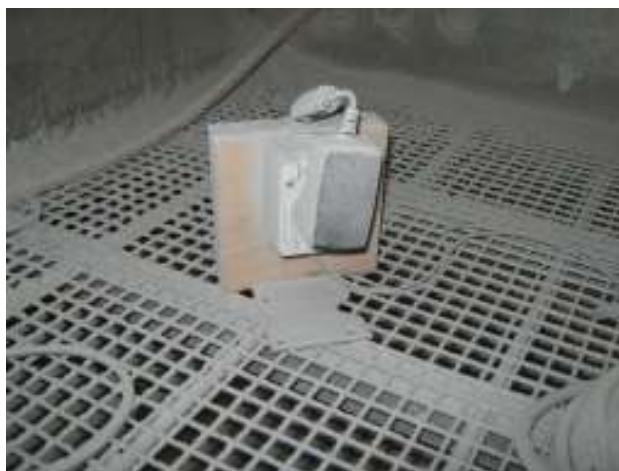
- Test chamber-as specified in standard,
- Dust, used for the test: talcum powder,
- Environmental temperature 24⁰C,
- No under pressure inside the enclosure,
- Duration of the exposure: 8 hours

Figure 5: EUT after the dust test

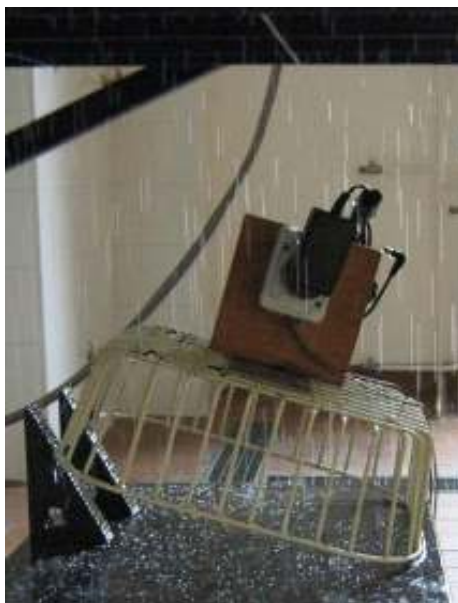
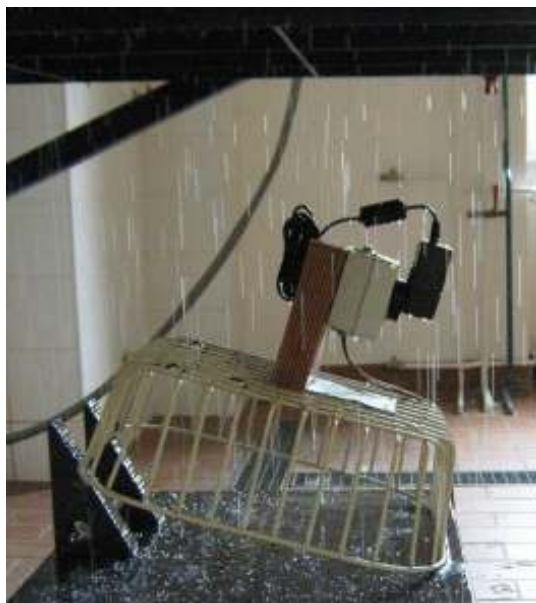
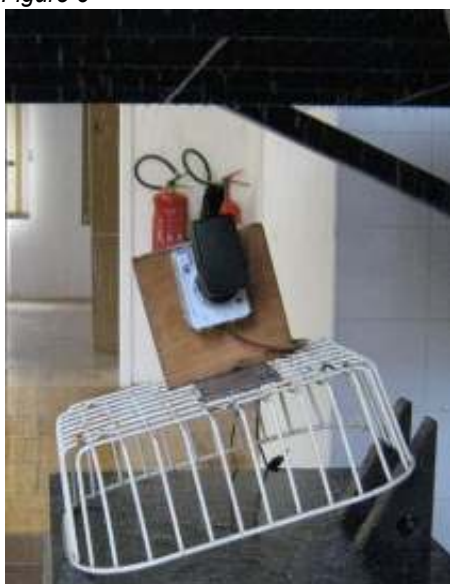
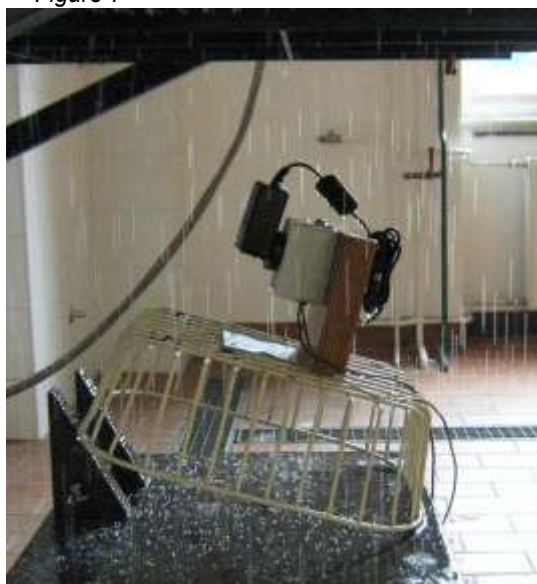
- Test device, drip box-as specified in standard,
- Water flow rate: 3 mm/min,
- The position of the test sample was fixed on 15⁰ on either side of the vertical in two mutually perpendicular planes,
- The test sample was tested for 2.5 minutes in each of four fixed positions (Figures 6 to 9),
- The total duration of the exposure was 10 minutes

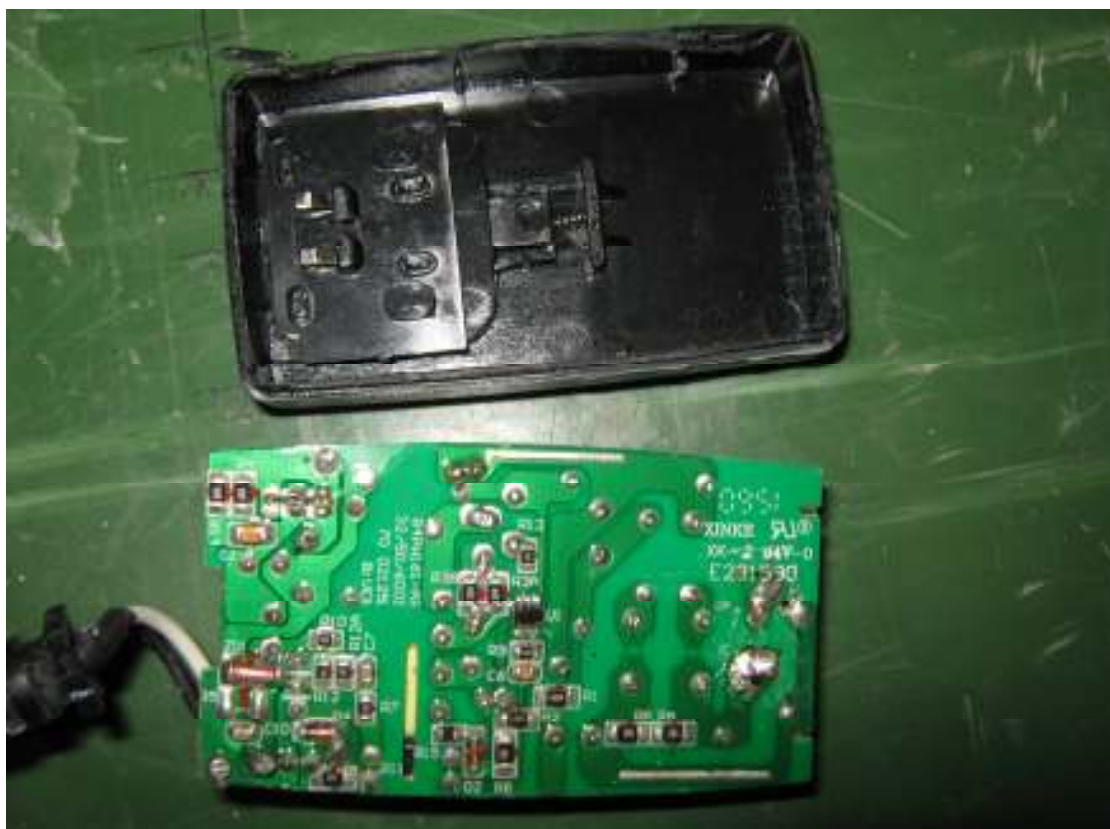
Figure 10

Conclusion: After the tests the enclosure was opened. There was no dust and no water inside the enclosure (Figures 10 and 11).

- There was no dust and no water inside the enclosure.
- There was no break down during the dielectric strength test.
