Poročilo o preskusu / Test Report

T211-0452/12

Proizvod / Product Power supply Model: GT-9100PWWVV-X.X GTM9100PWWVV-X.X Enclosure: TR9CX2500LCP-C(R)	Listov / Pages 3
Naročnik / Applicant GlobTek, Inc 186 Veterans Dr, Northvale, NJ 07647 / USA	Vrsta preskusa / Test procedure IP40, IP41
Proizvajalec / Manufacturer GlobTek, Inc 186 Veterans Dr, Northvale, NJ 07647 / USA	Št. Merjencev / No. of Items tested 1
Blagovna znamka / Trade Mark GlobTek	Mapa predmeta št. / Subject File No. C20121557
Standardi – predpisi / Standards - regulations IEC 60529:2001	Kraj preskusa / Place of test SIQ - Slovenian Institute of Quality and Metrology, Tržaška 2, 1000 Ljubljana, Slovenia
	Opomba / Remark /

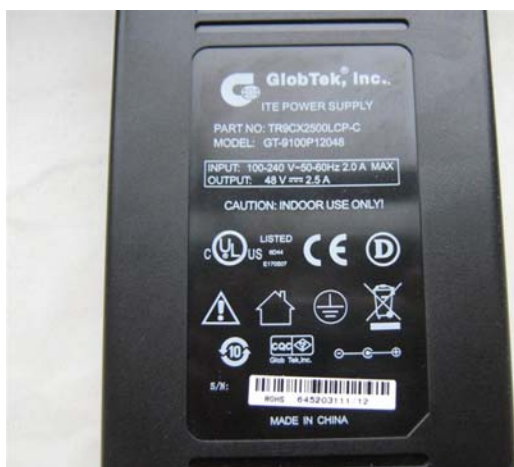
Figure 1

Power supply, model GT-9100PWWV-V.X and GTM9100PWWV-V.X, enclosure TR9CX2500LCP-C(R) was subjected to testing for IP41 degree of protection (Figures 1 and 2).
