Poročilo o preskusu / Test Report

T211-0480/12

Proizvod / Product	Listov / Pages
Power supply Model: GT-21089-WVVV-X.X-W3Z series GTM21089-WVVV-X.X-W3Z series, GT-41080-WVVV-X.X-W3Zseries GTM41080-WVVV-X.X-W3Z series GTM91075-6012-W3E GT-41080-WVVV-X.X-W3E, Enclosure: WR92A2600CCP-Y(R)	4
Naročnik / Applicant	Vrsta preskusa / Test procedure
GlobTek, Inc 186 Veterans Dr, Northvale, NJ 07647 / USA	IP40, IP41
Proizvajalec / Manufacturer	Št. Merjencev / No. of Items tested
GlobTek, Inc 186 Veterans Dr, Northvale, NJ 07647 / USA	1
Blagovna znamka / Trade Mark	Mapa predmeta št. / Subject File No.
GlobTek	C20121557
Standardi – predpisi / Standards - regulations	Kraj preskusa / Place of test
IEC 60529:2001	SIQ - Slovenian Institute of Quality and Metrology, Tržaška 2, 1000 Ljubljana, Slovenia
	Opomba / Remark
	/

Tested product complies with the requirements of stated standards for protection degree IP 40.

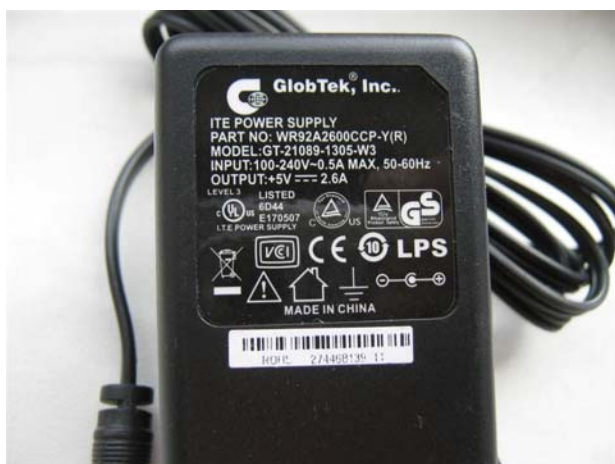
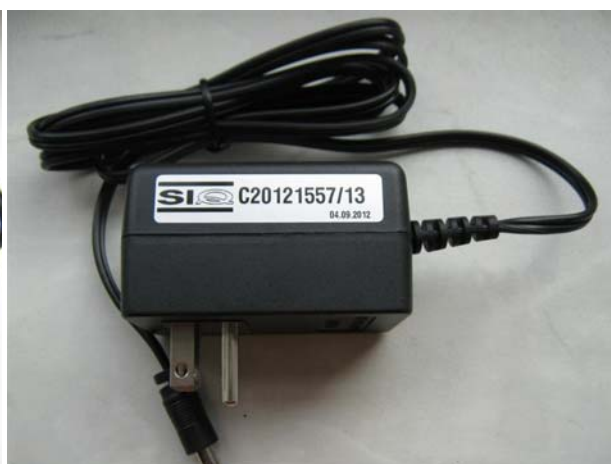
Figure 1

Power supply, model GT-21089-WWVV-X.X-W3Z series, GTM21089-WWVV-X.X-W3Z series, GT-41080-WWVV-X.X-W3Z series, GTM41080-WWVV-X.X-W3Z series, GTM91075-6012-W3E and GT-41080-WWVV-X.X-W3E, enclosure WR92A2600CCP-Y(R) was subjected to testing for IP41 degree of protection (Figures 1 and 2).

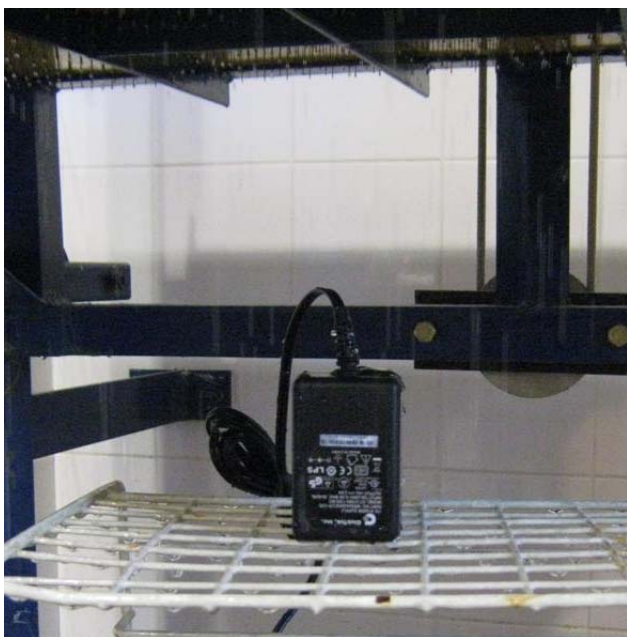
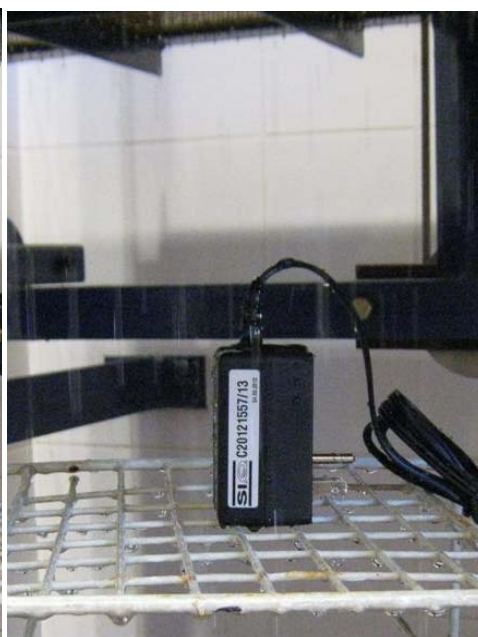
Figure 3: Test position

- Test device, drip box-as specified in standard,
- Water flow rate: 1 mm/min,
- The test sample was placed on the turntable under the drip box in most unfavourable normal position (Figures 3 and 4),
- Duration of the exposure: 10 minutes,
