**Test Report**

Report No.: SZ201303010085E-A -1 Date: 2013/04/09

Sample Name : Power Supply  
Sample Type : GTM91099  
Sample Quantity : 3units  
Date Submitted : Mar.12, 2013  
Test Period : Mar.12, 2013~ Mar.26, 2013

Test Request : To perform dust proof test and water proof test (IP54) on submitted sample as client specified.  
Test Methods : (1) Refer to GB/T 4208-2008 Degrees of protection provided by enclosure (IP code).  
Test Result : Please refer to next pages.

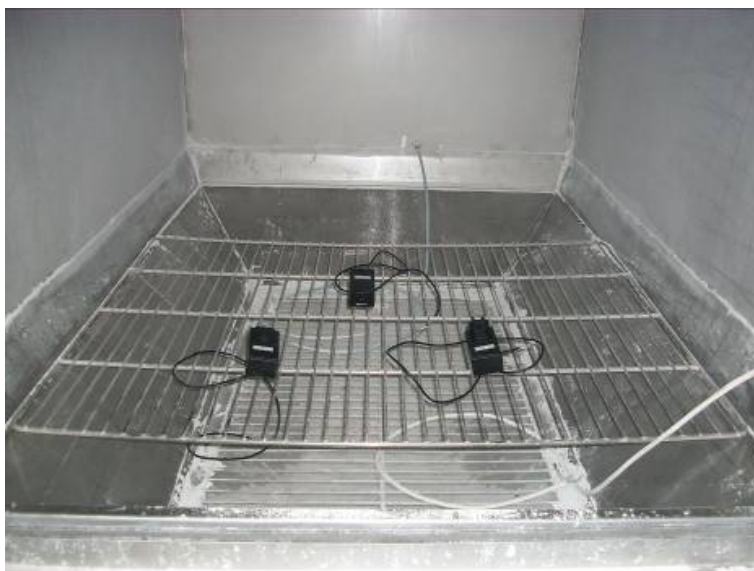
Fig.2: Photos of dust proof test and water proof test process

Dust proof test

<u>Sample Name</u>	: Power Supply
<u>Sample No.</u>	: 201303010085-001~003
<u>Test Ambient</u>	: Temperature: 25°C; Humidity:55%RH
<u>Test Condition</u>	: Put the sample into the dust chamber, closed the door of the dust chamber, operate the fan, so the talcum powder is in suspension, keep the sample for 8 hours with the talcum powder in suspension , then take out the sample, observe whether the dust run into the inner of the sample.
<u>Test Process</u>	: Fig.2
<u>Test Method</u>	: Refer to (1)
<u>Test Result</u>	: Dust proof test was performed on submitted sample as client specified. After test, no dust was observed in inner of all samples.
<u>Photo after Test</u>	: Fig.3

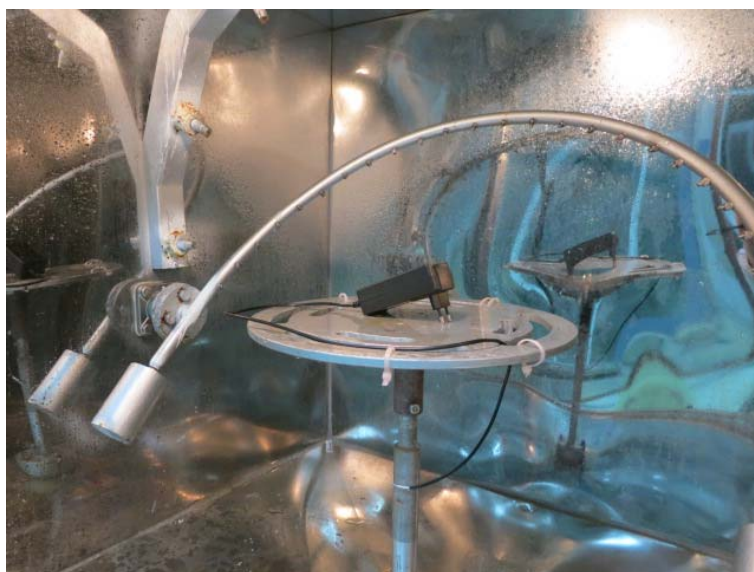
Water proof test

<u>Sample Name</u>	: Power Supply
<u>Sample No.</u>	: 201303010085-002~003
<u>Test Ambient</u>	: Temperature: 18°C; Humidity:53%RH
<u>Test Condition</u>	: Test time:10min; aperture is 0.4 mm and the angle between aperture and vertical is 90°, spray when rolling roll tube to $\pm (180^\circ \sim 20^\circ)$ , the maximum distance between the sample and the roll tube is 200 mm.
<u>Test Process</u>	: Fig.2
<u>Test Method</u>	: Refer to (1)
<u>Test Result</u>	: Water proof test was performed on submitted sample as client specified. After test, no water was observed in inner of all samples.
<u>Photo after Test</u>	: Fig.3

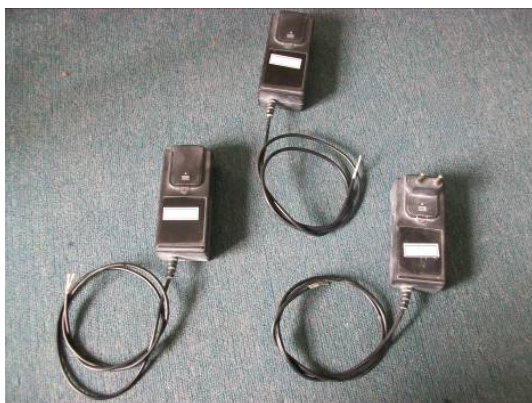
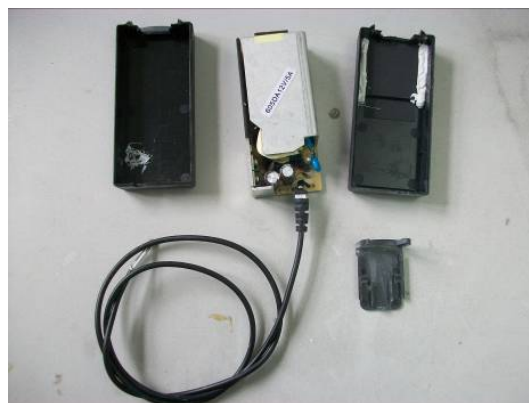
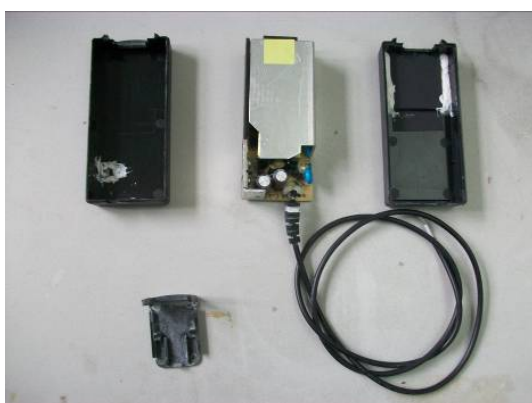
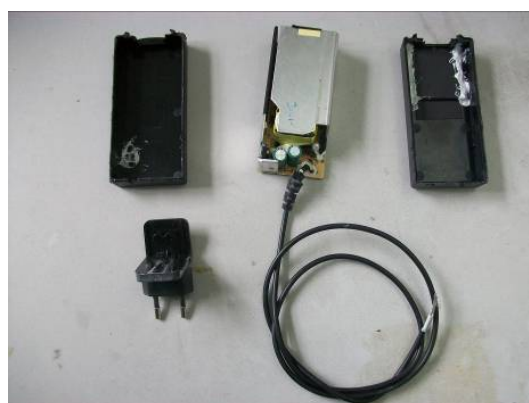
Fig.3: Photos of appearance and inside of the samples after test

After dust proof test

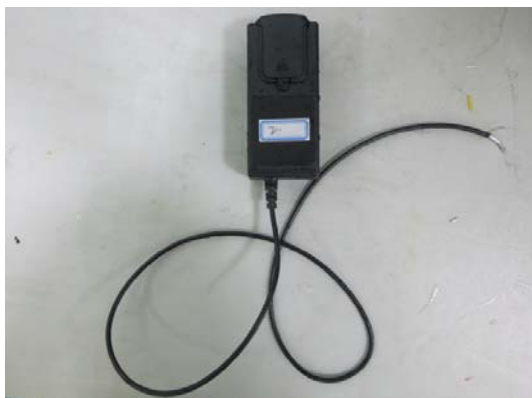
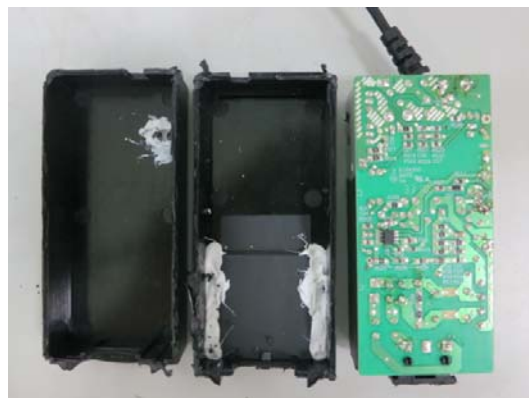
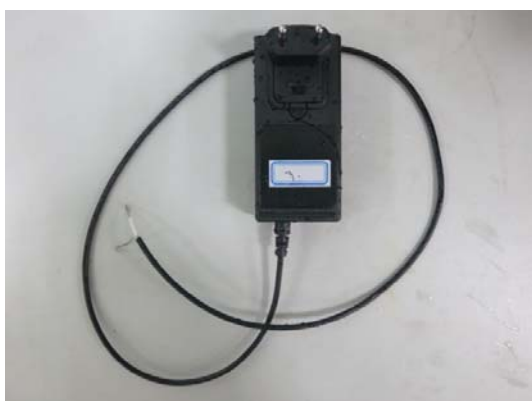
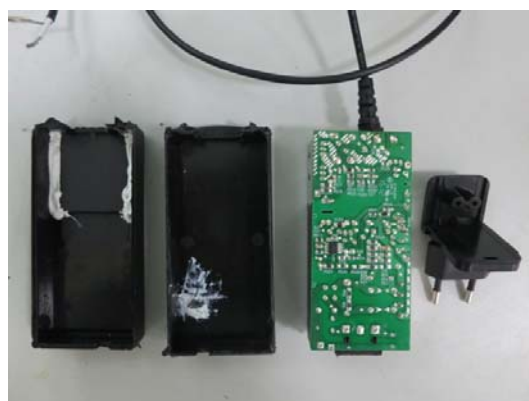
Fig.3: Appearance and inside photos of the samples after test (continued)

After water proof test
