Poročilo o preskusu / Test Report

T211-0463/12

Proizvod / Product Power supply Model: GT-21089-WWVV-X.X-T2 series GTM21089-WWVV-X.X-T2 series Enclosure: TR9KA2600LCP-Y(R)	Listov / Pages 3
Naročnik / Applicant GlobTek, Inc 186 Veterans Dr, Northvale, NJ 07647 / USA	Vrsta preskusa / Test procedure IP40, IP41
Proizvajalec / Manufacturer GlobTek, Inc 186 Veterans Dr, Northvale, NJ 07647 / USA	Št. Merjencev / No. of Items tested 1
Blagovna znamka / Trade Mark GlobTek	Mapa predmeta št. / Subject File No. C20121557
Standardi – predpisi / Standards - regulations IEC 60529:2001	Kraj preskusa / Place of test SIQ - Slovenian Institute of Quality and Metrology, Tržaška 2, 1000 Ljubljana, Slovenia
	Opomba / Remark /

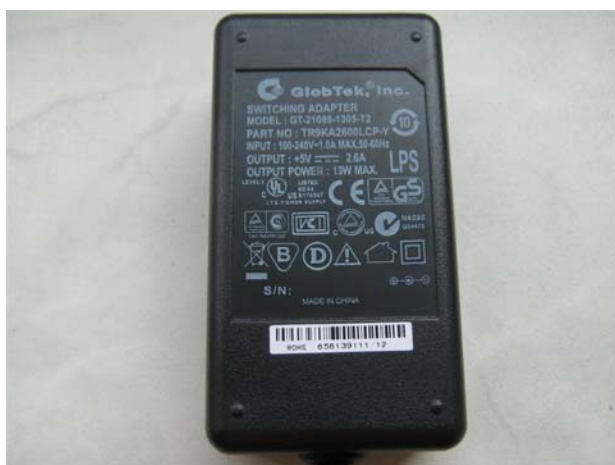
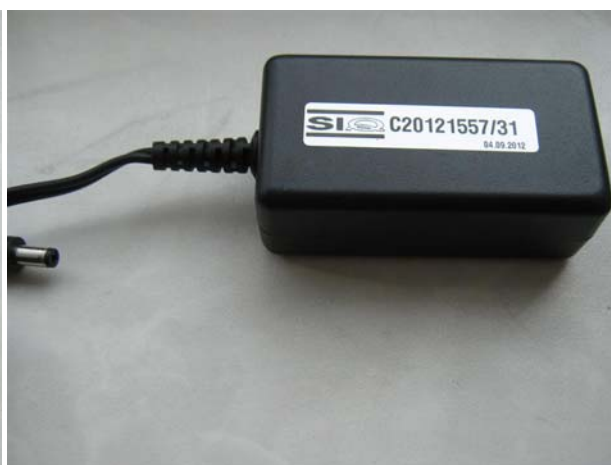
Power supply, model GT-21089-WWVV-X.X-T2 series and GTM21089-WWVV-X.X-T2 series, enclosure TR9KA2600LCP-Y(R) was subjected to testing for IP41 degree of protection (Figures 1 and 2).
