Poročilo o preskusu / Test Report

T211-0450/12

Proizvod / Product Power supply Model: GT-21089-WVVV-X.X-T3 series GTM21089-WVVV-X.X-T3 series Enclosure: TR9CA2600KCP-Y(R)	Listov / Pages 3
Naročnik / Applicant GlobTek, Inc 186 Veterans Dr, Northvale, NJ 07647 / USA	Vrsta preskusa / Test procedure IP40, IP41
Proizvajalec / Manufacturer GlobTek, Inc 186 Veterans Dr, Northvale, NJ 07647 / USA	Št. Merjencev / No. of Items tested 1
Blagovna znamka / Trade Mark GlobTek	Mapa predmeta št. / Subject File No. C20121557
Standardi – predpisi / Standards - regulations IEC 60529:2001	Kraj preskusa / Place of test SIQ - Slovenian Institute of Quality and Metrology, Tržaška 2, 1000 Ljubljana, Slovenia
	Opomba / Remark /

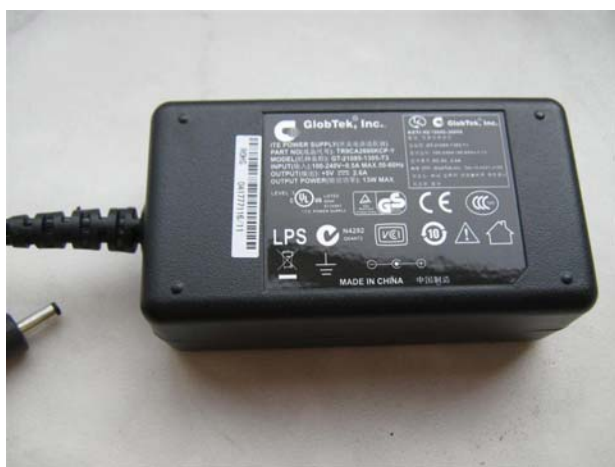
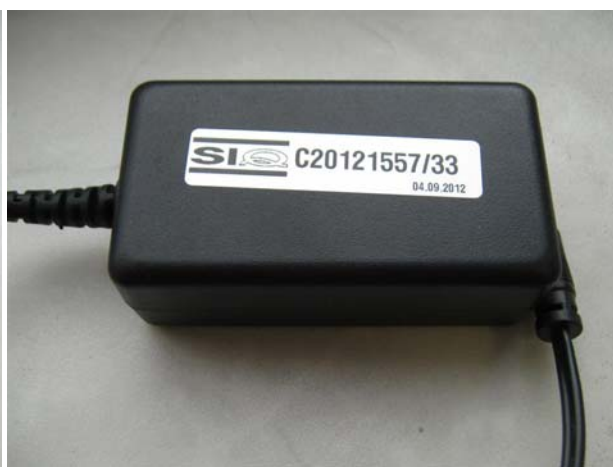
Figure 1

Power supply, model GT-21089-WWVV-X.X-T3 series and GTM21089-WWVV-X.X-T3 series, enclosure TR9CA2600KCP-Y(R) was subjected to testing for IP41 degree of protection (Figures 1 and 2).

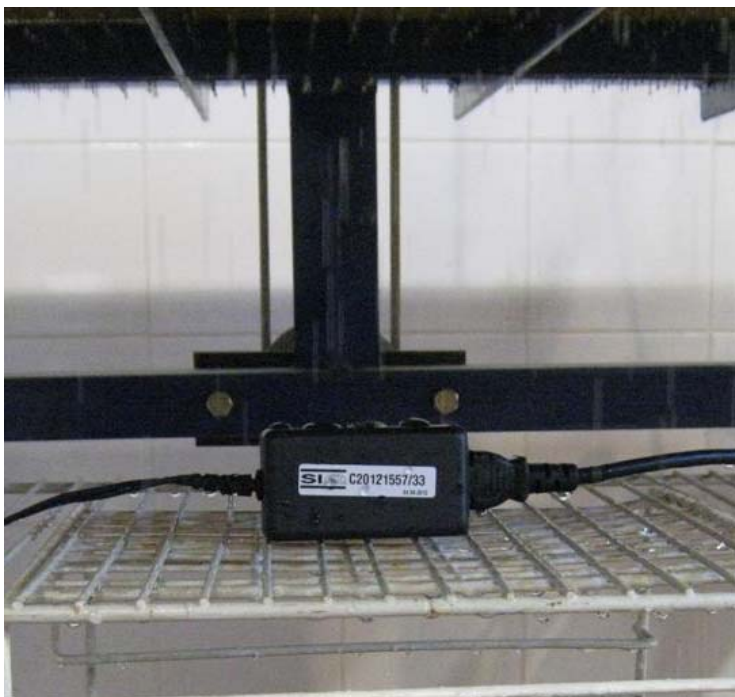
- Test device, drip box-as specified in standard,
- Water flow rate: 1 mm/min,
- The test sample was placed on the turntable under the drip box in most unfavourable normal position (Figure 3),
- Duration of the exposure: 10 minutes,

Figure 3: Test position

Conclusion: After the water test there was water on the connector pins.

Immediately following the water test the dielectric strength test with 4000 V a.c. has been conducted between primary and secondary terminals and between primary terminals and enclosure. The voltage was applied and maintained for a period of one minute between the points indicated. The test did NOT pass.
