# Poročilo o preskusu / Test Report

T211-0461/12

<b>Proizvod / Product</b> Power supply Model: GT-41130-WWVV-X.X-T3A series, GT-43006-WWVV-X.X-T3A series GT-41062-WWVV-X.X-T3A series, GT-41082-WWVV-X.X-T3A series Enclosure: TR9LA3600KCP-N(RVB)	<b>Listov / Pages</b> 3
<b>Naročnik / Applicant</b> GlobTek, Inc 186 Veterans Dr, Northvale, NJ 07647 / USA	<b>Vrsta preskusa / Test procedure</b> IP40, IP41
<b>Proizvajalec / Manufacturer</b> GlobTek, Inc 186 Veterans Dr, Northvale, NJ 07647 / USA	<b>Št. Merjencev / No. of Items tested</b> 1
<b>Blagovna znamka / Trade Mark</b> GlobTek	<b>Mapa predmeta št. / Subject File No.</b> C20121557
<b>Standardi – predpisi / Standards - regulations</b> IEC 60529:2001	<b>Kraj preskusa / Place of test</b> SIQ - Slovenian Institute of Quality and Metrology, Tržaška 2, 1000 Ljubljana, Slovenia
	<b>Opomba / Remark</b> /

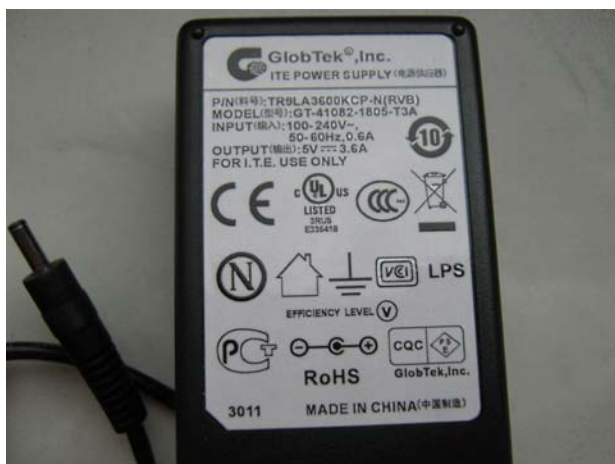
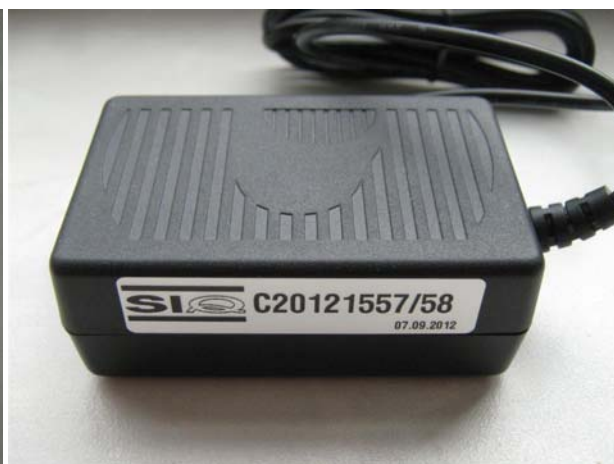
Figure 1

Power supply, model GT-41130-WWVV-X.X-T3A series, GT-43006-WWVV-X.X-T3A series, GT-41062-WWVV-X.X-T3A series and GT-41082-WWVV-X.X-T3A series, enclosure TR9LA3600KCP-N(RVB) was subjected to testing for IP41 degree of protection (Figures 1 and 2).

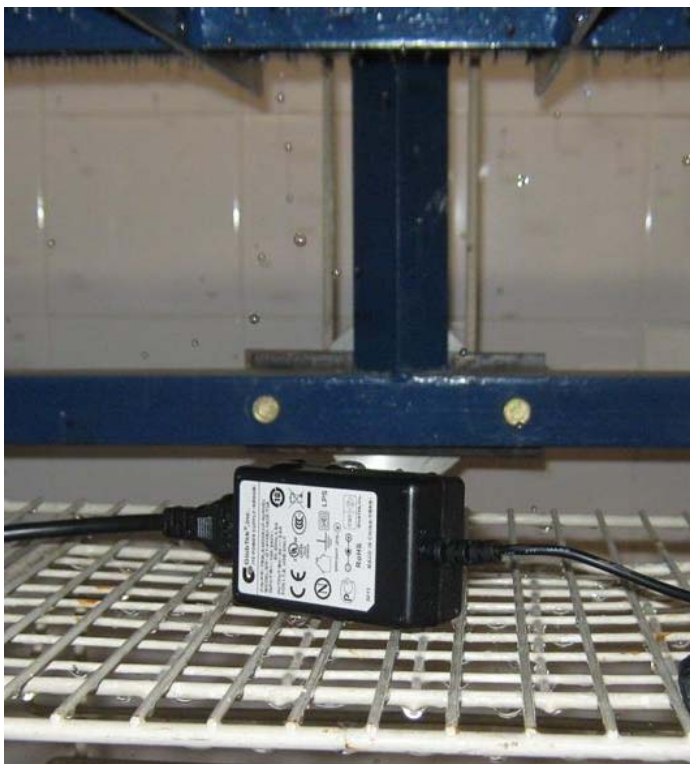
- Test device, drip box-as specified in standard,
- Water flow rate: 1 mm/min,
- The test sample was placed on the turntable under the drip box in most unfavourable normal position (Figure 3),
- Duration of the exposure: 10 minutes,

Figure 3: Test position

**Conclusion:** After the water test there was water on the connector pins.

Immediately following the water test the dielectric strength test with 4000 V a.c. has been conducted between primary and secondary terminals and between primary terminals and enclosure. The voltage was applied and maintained for a period of one minute between the points indicated. The test did NOT pass.

- The rigid test wire was not penetrated into the enclosure
- After the IPX1 test there was water on connector pins.
- After the IPX1 test the dielectric strength test did NOT pass.
