# Poročilo o preskusu / Test Report

T211-0467/12

<b>Proizvod / Product</b> Power supply Model: GT-41132-WWVV-X.X-T2 series GT-43008-WWVV-X.X-T2 series Enclosure: TR9KH3330MLX-N(RVB)	<b>Listov / Pages</b> 3
<b>Naročnik / Applicant</b> GlobTek, Inc 186 Veterans Dr, Northvale, NJ 07647 / USA	<b>Vrsta preskusa / Test procedure</b> IP40, IP41
<b>Proizvajalec / Manufacturer</b> GlobTek, Inc 186 Veterans Dr, Northvale, NJ 07647 / USA	<b>Št. Merjencev / No. of Items tested</b> 1
<b>Blagovna znamka / Trade Mark</b> GlobTek	<b>Mapa predmeta št. / Subject File No.</b> C20121557
<b>Standardi – predpisi / Standards - regulations</b> IEC 60529:2001	<b>Kraj preskusa / Place of test</b> SIQ - Slovenian Institute of Quality and Metrology, Tržaška 2, 1000 Ljubljana, Slovenia
	<b>Opomba / Remark</b> /

Power supply, model GT-41132-WWVV-X.X-T2 series and GT-43008-WWVV-X.X-T2 series, enclosure TR9KH3330MLX-N(RVB) was subjected to testing for IP41 degree of protection (Figures 1 and 2).

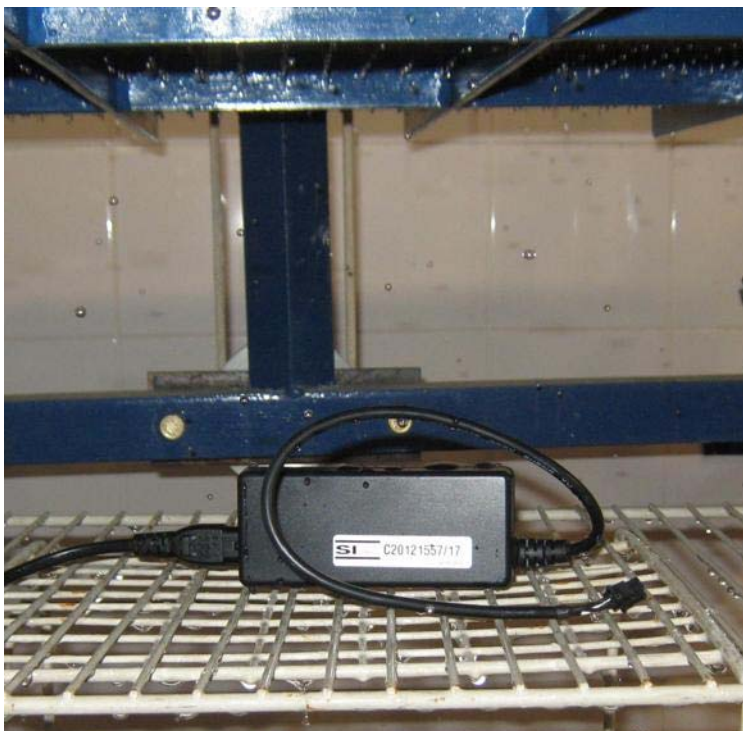
- Test device, drip box-as specified in standard,
- Water flow rate: 1 mm/min,
- The test sample was placed on the turntable under the drip box in most unfavourable normal position (Figure 3),
- Duration of the exposure: 10 minutes,

Figure 3: Test position

**Conclusion:** After the water test there was water on the connector pins.

Immediately following the water test the dielectric strength test with 4000 V a.c. has been conducted between primary and secondary terminals and between primary terminals and enclosure. The voltage was applied and maintained for a period of one minute between the points indicated. The test did NOT pass.

- The rigid test wire was not penetrated into the enclosure
- After the IPX1 test there was water on connector pins.
- After the IPX1 test the dielectric strength test did NOT pass.
