Poročilo o preskusu / Test Report

T211-0454/12

Proizvod / Product Power supply Model: GT-41132-WVVV-X.X-T3 series GT-43008-WVVV-X.X-T3 series Enclosure: TR9CE5000LR10N(RVB)	Listov / Pages 3
Naročnik / Applicant GlobTek, Inc 186 Veterans Dr, Northvale, NJ 07647 / USA	Vrsta preskusa / Test procedure IP40, IP41
Proizvajalec / Manufacturer GlobTek, Inc 186 Veterans Dr, Northvale, NJ 07647 / USA	Št. Merjencev / No. of Items tested 1
Blagovna znamka / Trade Mark GlobTek	Mapa predmeta št. / Subject File No. C20121557
Standardi – predpisi / Standards - regulations IEC 60529:2001	Kraj preskusa / Place of test SIQ - Slovenian Institute of Quality and Metrology, Tržaška 2, 1000 Ljubljana, Slovenia
	Opomba / Remark /

Tested product complies with the requirements of stated standards for protection degree IP 40.

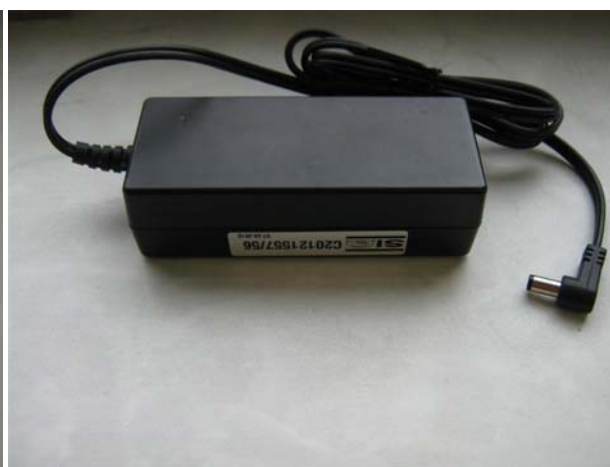
Figure 1

Power supply, model GT-41132-WVVV-X.X-T3 series and GT-43008-WVVV-X.X-T3 series, enclosure TR9CE5000LR10N(RVB) was subjected to testing for IP41 degree of protection (Figures 1 and 2).
