# Poročilo o preskusu / Test Report

T211-0464/12

Power supply

Model: GT-41132-WWVV-X.X-T3A series GT-43008-WWVV-X.X-T3A series Enclosure: TR9LE5000N05-N(RVB)

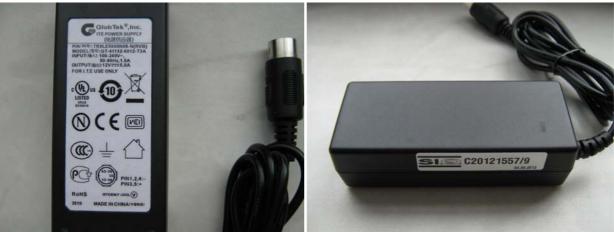
Figure 1 Figure 2

Power supply, model GT-41132-WWVV-X.X-T3A series and GT-43008-WWVV-X.X-T3A series, enclosure TR9LE5000N05-N(RVB) was subjected to testing for IP41 degree of protection (Figures 1 and 2).

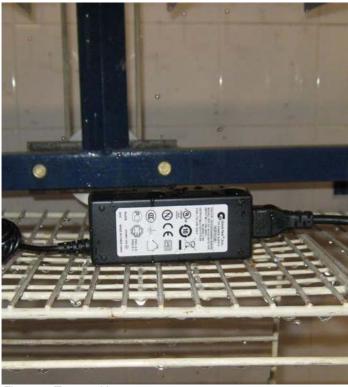
Figure 3: Test position

- Test device, drip box-as specified in standard,
- Water flow rate: 1 mm/min,
- The test sample was placed on the turntable under the drip box in most unfavourable normal position (Figure 3),
- Duration of the exposure: 10 minutes,

**Conclusion:** After the water test there was water on the connector pins.

Immediately following the water test the dielectric strength test with 4000 V a.c. has been conducted between primary and secondary terminals and between primary terminals and enclosure. The voltage was applied and maintained for a period of one minute between the points indicated. The test did NOT pass.

- The rigid test wire was not penetrated into the enclosure
- After the IPX1 test there was water on connector pins.
- After the IPX1 test the dielectric strength test did NOT pass.

Result: Following the acceptance conditions, the equipment under test sustained the test conditions for IP40 degree of protection.
