Poročilo o preskusu / Test Report

T211-0449/12

Proizvod / Product Power supply Model: GT-5001VV-X.X series Enclosure: TR9CE4000LCP-R-MED(R)	Listov / Pages 3
Naročnik / Applicant GlobTek, Inc 186 Veterans Dr, Northvale, NJ 07647 / USA	Vrsta preskusa / Test procedure IP40, IP41
Proizvajalec / Manufacturer GlobTek, Inc 186 Veterans Dr, Northvale, NJ 07647 / USA	Št. Merjencev / No. of Items tested 1
Blagovna znamka / Trade Mark GlobTek	Mapa predmeta št. / Subject File No. C20121557
Standardi – predpisi / Standards - regulations IEC 60529:2001	Kraj preskusa / Place of test SIQ - Slovenian Institute of Quality and Metrology, Tržaška 2, 1000 Ljubljana, Slovenia
	Opomba / Remark /

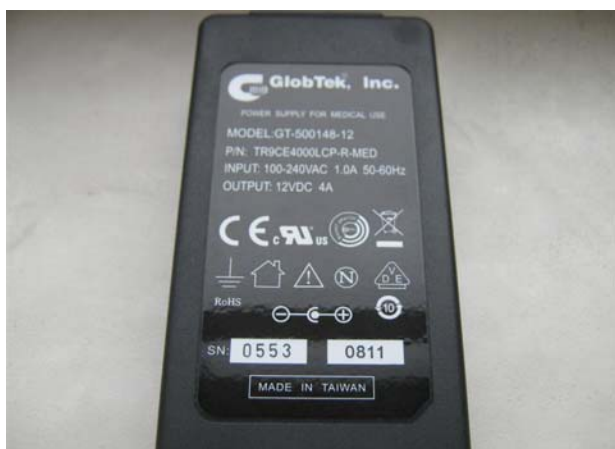
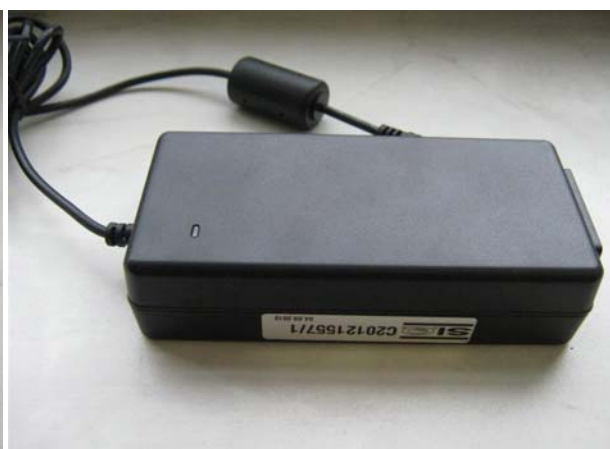
Figure 1

Power supply, model GT-5001VV-X.X series, enclosure TR9CE4000LCP-R-MED(R) was subjected to testing for IP41 degree of protection (Figures 1 and 2).

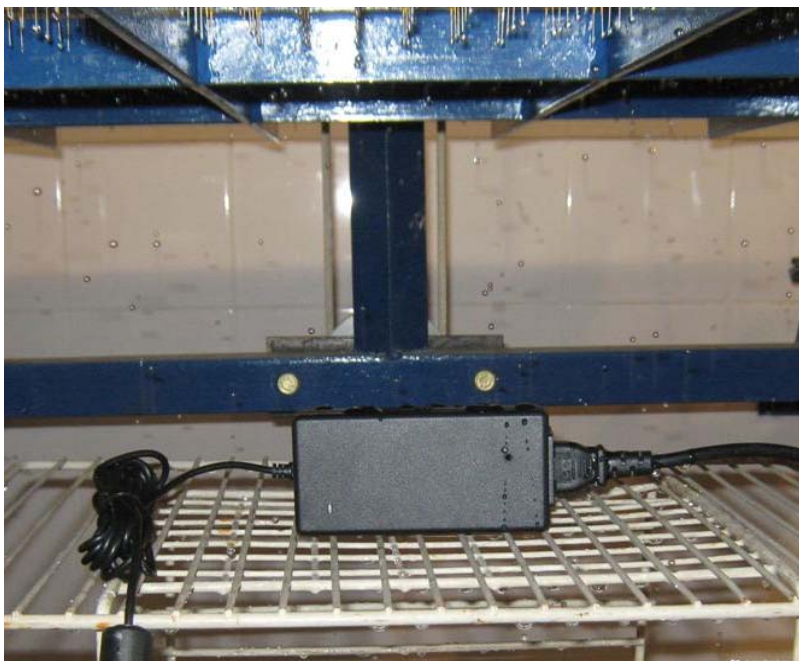
- Test device, drip box-as specified in standard,
- Water flow rate: 1 mm/min,
- The test sample was placed on the turntable under the drip box in most unfavourable normal position (Figure 3),
- Duration of the exposure: 10 minutes,

Figure 3: Test position

Conclusion: After the water test there was water on the connector pins.

Immediately following the water test the dielectric strength test with 4000 V a.c. has been conducted between primary and secondary terminals and between primary terminals and enclosure. The voltage was applied and maintained for a period of one minute between the points indicated. The test did NOT pass.

- The rigid test wire was not penetrated into the enclosure
- After the IPX1 test there was water on connector pins.
- After the IPX1 test the dielectric strength test did NOT pass.
