Slovenski inštitut za
kakovost in meroslovje
Slovenian Institute of
Quality and Metrology

Poročilo o preskusu / Test Report

T211-0452/12

Proizvod / Product Power supply Model: GT-9100PWWVV-X.X GTM9100PWWVV-X.X Enclosure: TR9CX2500LCP-C(R)	Listov / Pages 3
Naročnik / Applicant GlobTek, Inc 186 Veterans Dr, Northvale, NJ 07647 / USA	Vrsta preskusa / Test procedure IP40, IP41
Proizvajalec / Manufacturer GlobTek, Inc 186 Veterans Dr, Northvale, NJ 07647 / USA	Št. Merjencev / No. of Items tested 1
Blagovna znamka / Trade Mark GlobTek	Mapa predmeta št. / Subject File No. C20121557
Standardi – predpisi / Standards - regulations IEC 60529:2001	Kraj preskusa / Place of test SIQ - Slovenian Institute of Quality and Metrology, Tržaška 2, 1000 Ljubljana, Slovenia
	Opomba / Remark /

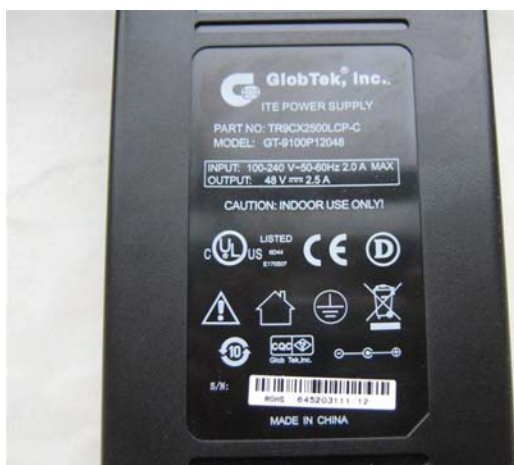
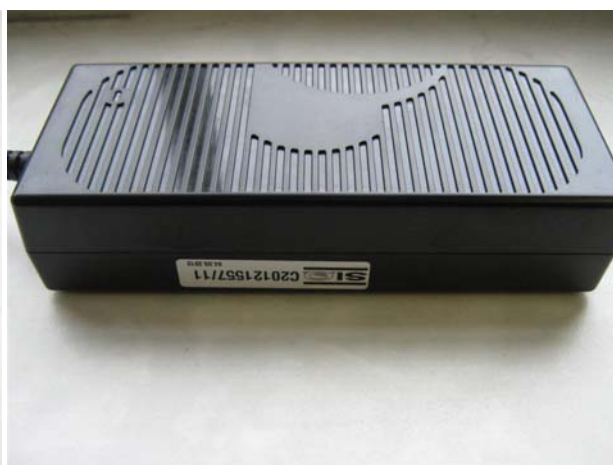
Figure 1

Power supply, model GT-9100PWWV-V.X and GTM9100PWWV-V.X, enclosure TR9CX2500LCP-C(R) was subjected to testing for IP41 degree of protection (Figures 1 and 2).
