# Poročilo o preskusu / Test Report

T211-0450/12

Power supply

Model: GT-21089-WWVV-X.X-T3 series GTM21089-WWVV-X.X-T3 series

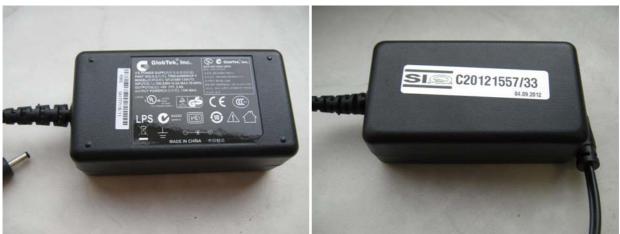
Figure 1 Figure 2

Power supply, model GT-21089-WWVV-X.X-T3 series and GTM21089-WWVV-X.X-T3 series, enclosure TR9CA2600KCP-Y(R) was subjected to testing for IP41 degree of protection (Figures 1 and 2).

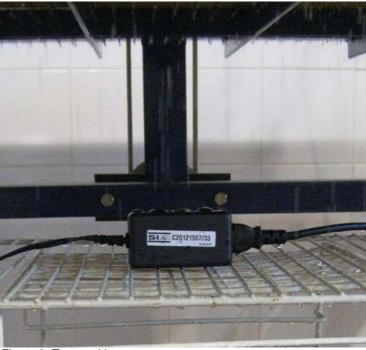
Figure 3: Test position

- Test device, drip box-as specified in standard,
- Water flow rate: 1 mm/min,
- The test sample was placed on the turntable under the drip box in most unfavourable normal position (Figure 3),
- Duration of the exposure: 10 minutes,

**Conclusion:** After the water test there was water on the connector pins.

Immediately following the water test the dielectric strength test with 4000 V a.c. has been conducted between primary and secondary terminals and between primary terminals and enclosure. The voltage was applied and maintained for a period of one minute between the points indicated. The test did NOT pass.

- The rigid test wire was not penetrated into the enclosure
- After the IPX1 test there was water on connector pins.
- After the IPX1 test the dielectric strength test did NOT pass.

Result: Following the acceptance conditions, the equipment under test sustained the test conditions for IP40 degree of protection.
