Poročilo o preskusu / Test Report

T211-0451/12

Proizvod / Product Power supply Model: GTM21097-WVVV-X.X series GT-21097-WVVV-X.X series GT-21126-WVVV-X.X Enclosure: TR9CA6000CCP-Y(R)	Listov / Pages 3
Naročnik / Applicant GlobTek, Inc 186 Veterans Dr, Northvale, NJ 07647 / USA	Vrsta preskusa / Test procedure IP40, IP41
Proizvajalec / Manufacturer GlobTek, Inc 186 Veterans Dr, Northvale, NJ 07647 / USA	Št. Merjencev / No. of Items tested 1
Blagovna znamka / Trade Mark GlobTek	Mapa predmeta št. / Subject File No. C20121557
Standardi – predpisi / Standards - regulations IEC 60529:2001	Kraj preskusa / Place of test SIQ - Slovenian Institute of Quality and Metrology, Tržaška 2, 1000 Ljubljana, Slovenia
	Opomba / Remark /

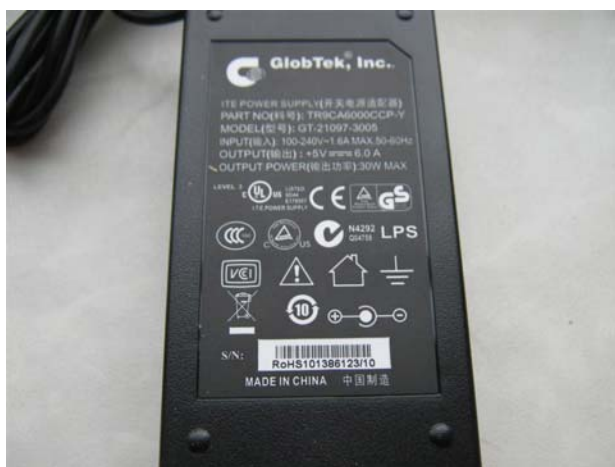
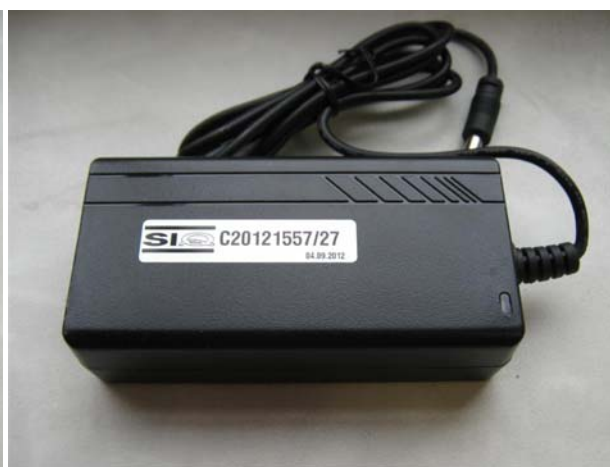
Figure 1

Power supply, model GTM21097-WWVV-X.X series, GT-21097-WWVV-X.X series and GT-21126-WWVV-X.X, enclosure TR9CA6000CCP-Y(R) was subjected to testing for IP41 degree of protection (Figures 1 and 2).

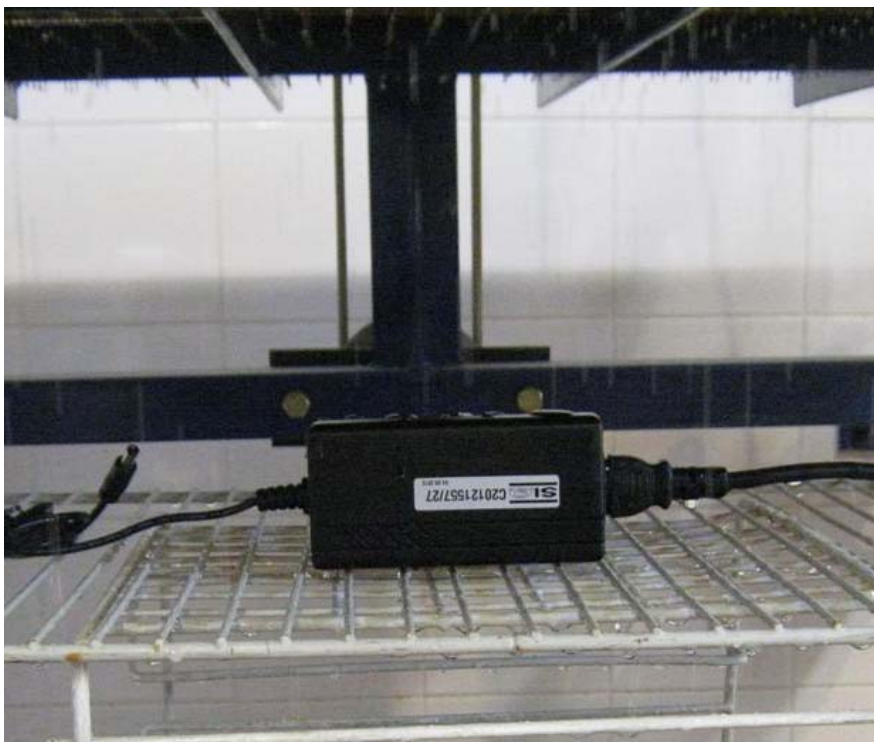
- Test device, drip box-as specified in standard,
- Water flow rate: 1 mm/min,
- The test sample was placed on the turntable under the drip box in most unfavourable normal position (Figure 3),
- Duration of the exposure: 10 minutes,

Figure 3: Test position

Conclusion: After the water test there was water on the connector pins.

Immediately following the water test the dielectric strength test with 4000 V a.c. has been conducted between primary and secondary terminals and between primary terminals and enclosure. The voltage was applied and maintained for a period of one minute between the points indicated. The test did NOT pass.

- The rigid test wire was not penetrated into the enclosure
- After the IPX1 test there was water on connector pins.
- After the IPX1 test the dielectric strength test did NOT pass.
