Poročilo o preskusu / Test Report

T211-0465/12

Proizvod / Product Power supply Model: GTM91120-WVVV-X.X-T3A series GT-91120-WVVV-X.X-T3A series Enclosure: RR9LA4000CCPYIM(RVB)	Listov / Pages 3
Naročnik / Applicant GlobTek, Inc 186 Veterans Dr, Northvale, NJ 07647 / USA	Vrsta preskusa / Test procedure IP40, IP41
Proizvajalec / Manufacturer GlobTek, Inc 186 Veterans Dr, Northvale, NJ 07647 / USA	Št. Merjencev / No. of Items tested 1
Blagovna znamka / Trade Mark GlobTek	Mapa predmeta št. / Subject File No. C20121557
Standardi – predpisi / Standards - regulations IEC 60529:2001	Kraj preskusa / Place of test SIQ - Slovenian Institute of Quality and Metrology, Tržaška 2, 1000 Ljubljana, Slovenia
	Opomba / Remark /

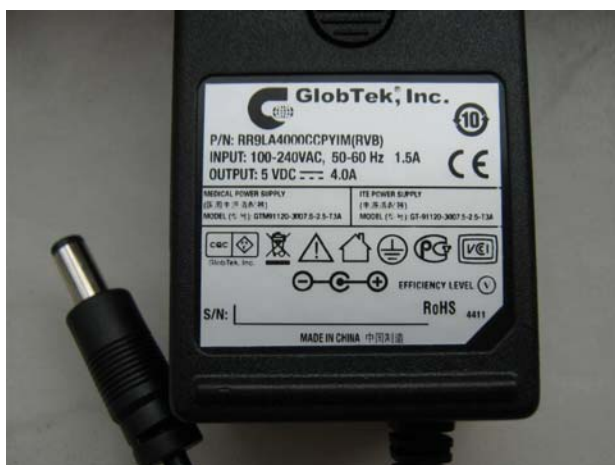
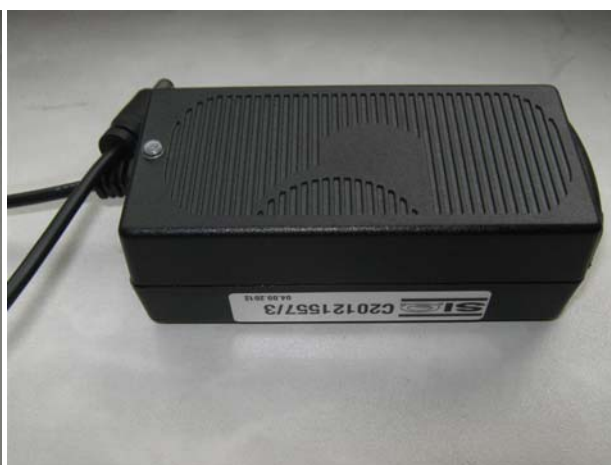
Figure 1

Power supply, model GTM91120-WWVV-X.X-T3A series and GT-91120-WWVV-X.X-T3A series, enclosure RR9LA4000CCPYIM(RVB) was subjected to testing for IP41 degree of protection (Figures 1 and 2).

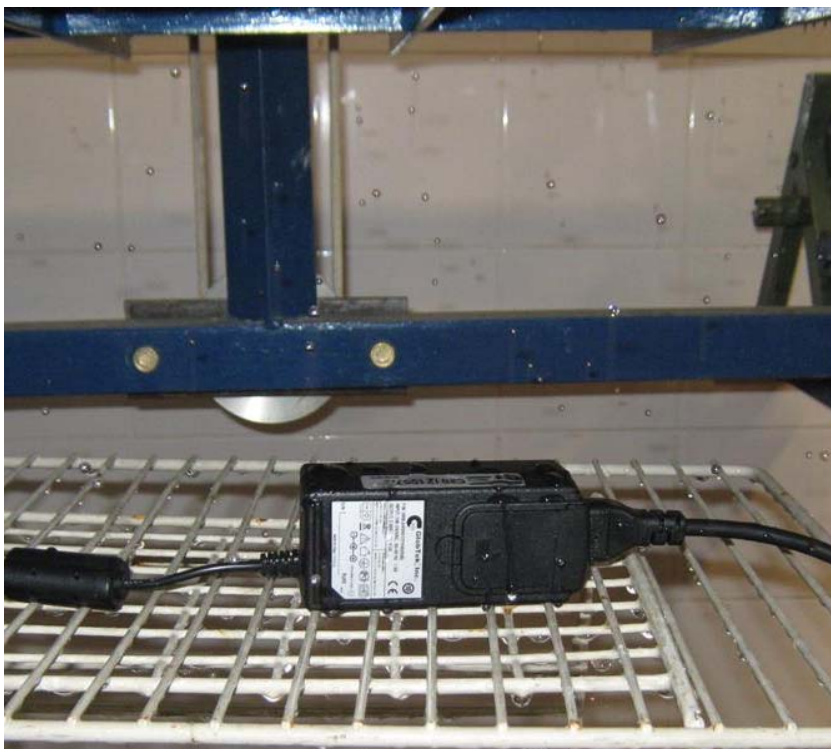
- Test device, drip box-as specified in standard,
- Water flow rate: 1 mm/min,
- The test sample was placed on the turntable under the drip box in most unfavourable normal position (Figure 3),
- Duration of the exposure: 10 minutes,

Figure 3: Test position

Conclusion: After the water test there was water on the connector pins.

Immediately following the water test the dielectric strength test with 4000 V a.c. has been conducted between primary and secondary terminals and between primary terminals and enclosure. The voltage was applied and maintained for a period of one minute between the points indicated. The test did NOT pass.

- The rigid test wire was not penetrated into the enclosure
- After the IPX1 test there was water on connector pins.
- After the IPX1 test the dielectric strength test did NOT pass.
